# **Building Envelope Inspection**

**How to Manage Risk and Reduce Liability**

**Online Class**

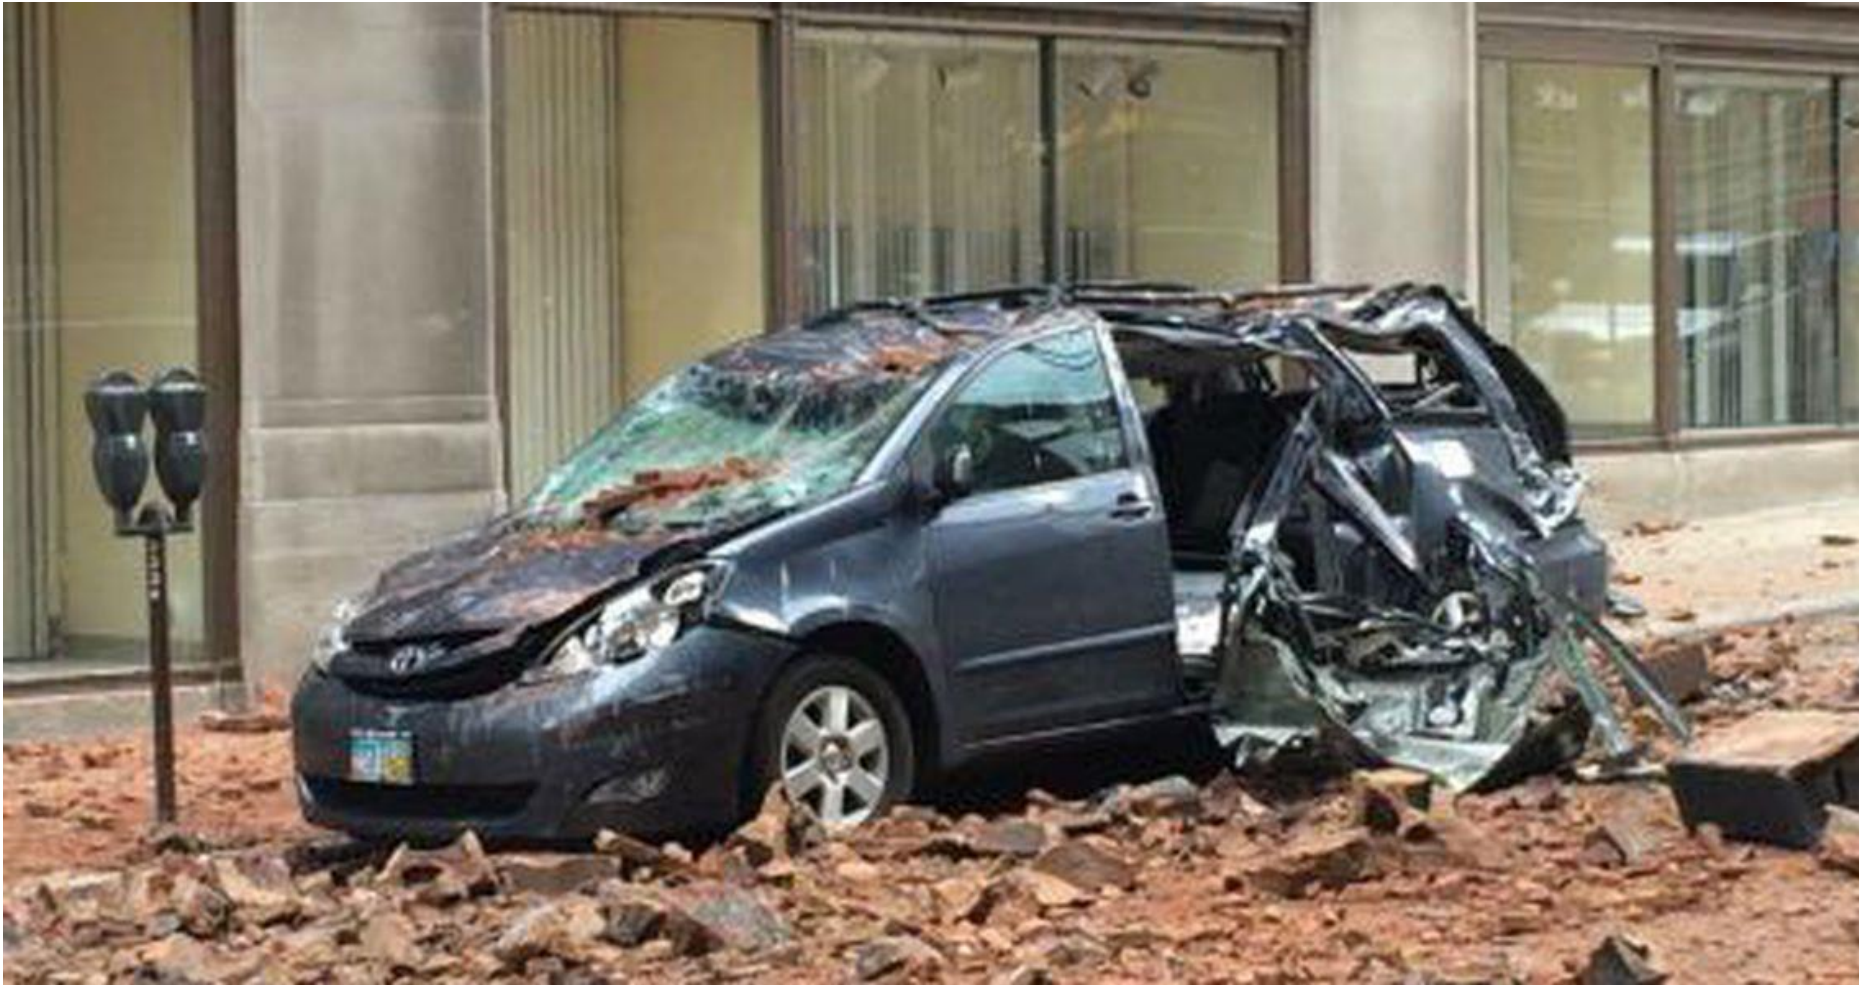
# Façade Collapse - Cleveland

- 2015
- Father & 4 Boys had just left car parked 10 minutes before to have dinner.
- High Winds Blamed

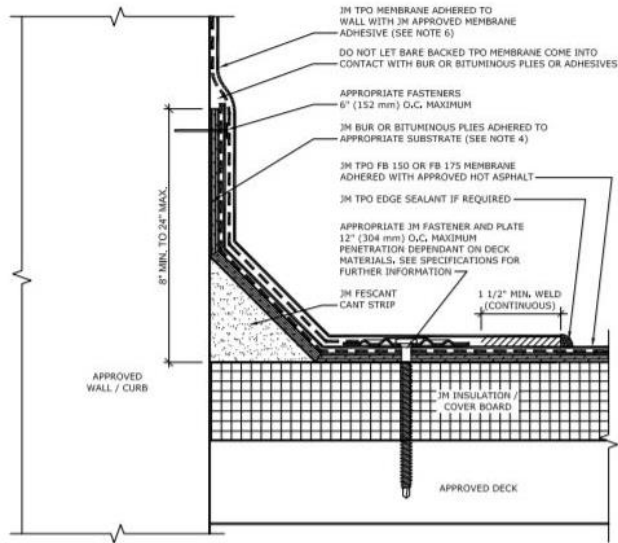
2 D

# Building Science - Transition Details

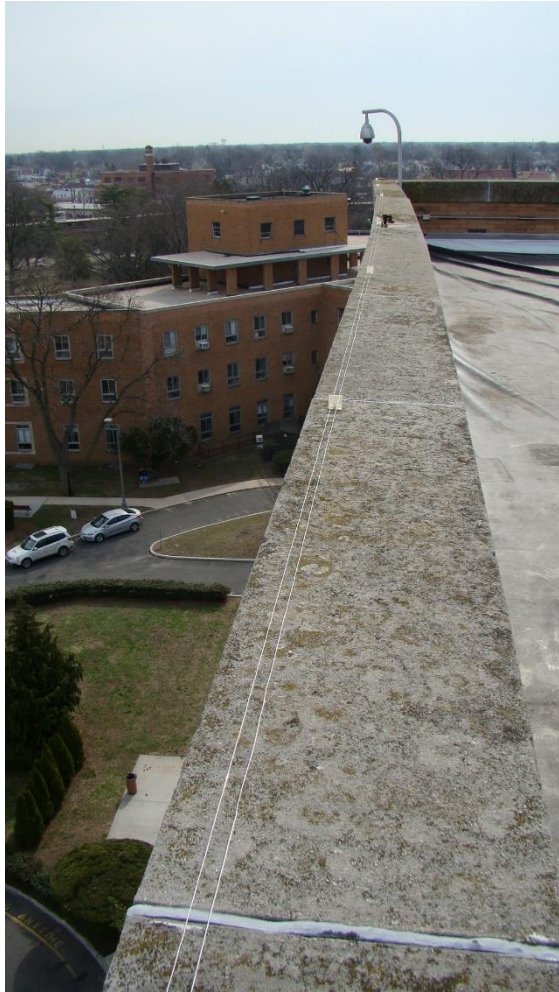
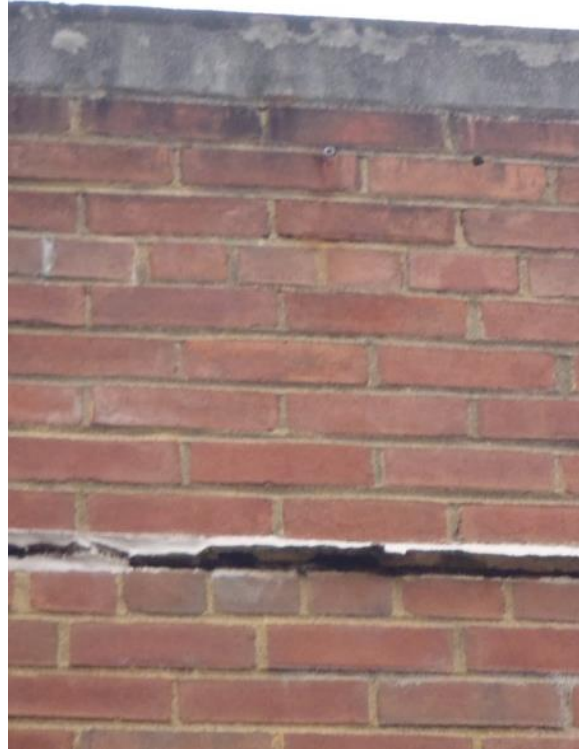
Bond Break  
at Roof Line

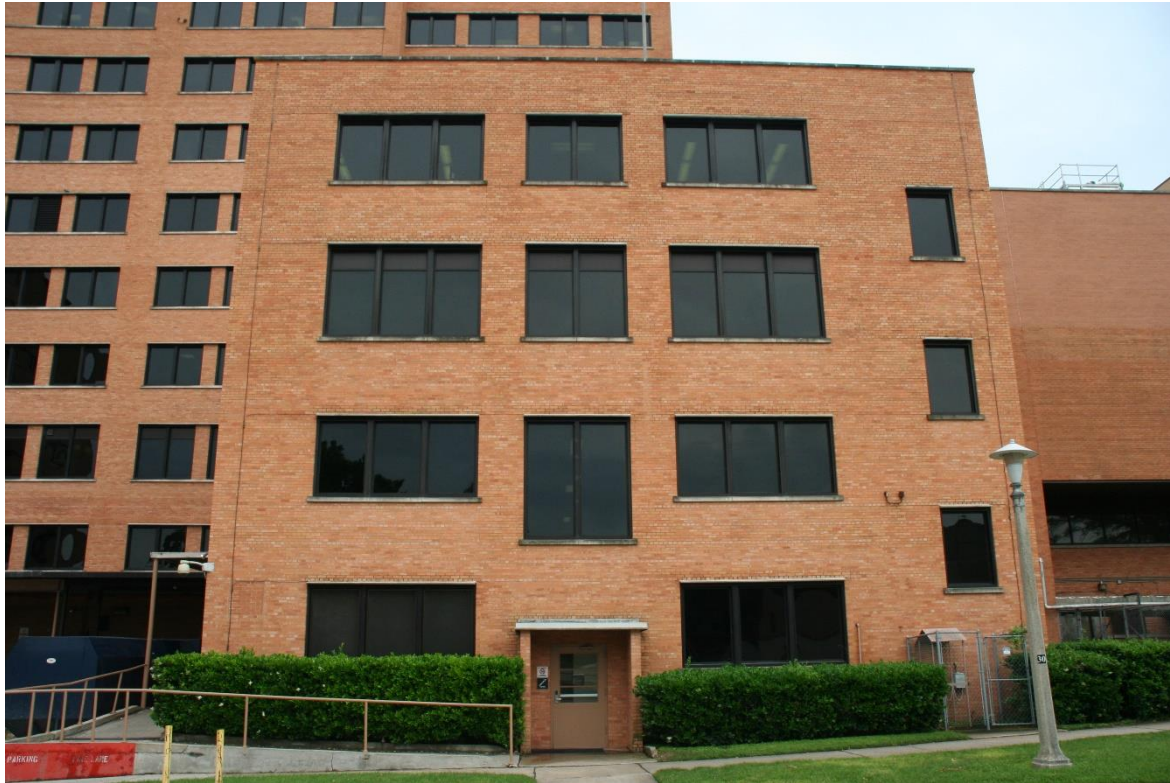
No Expansion Joints

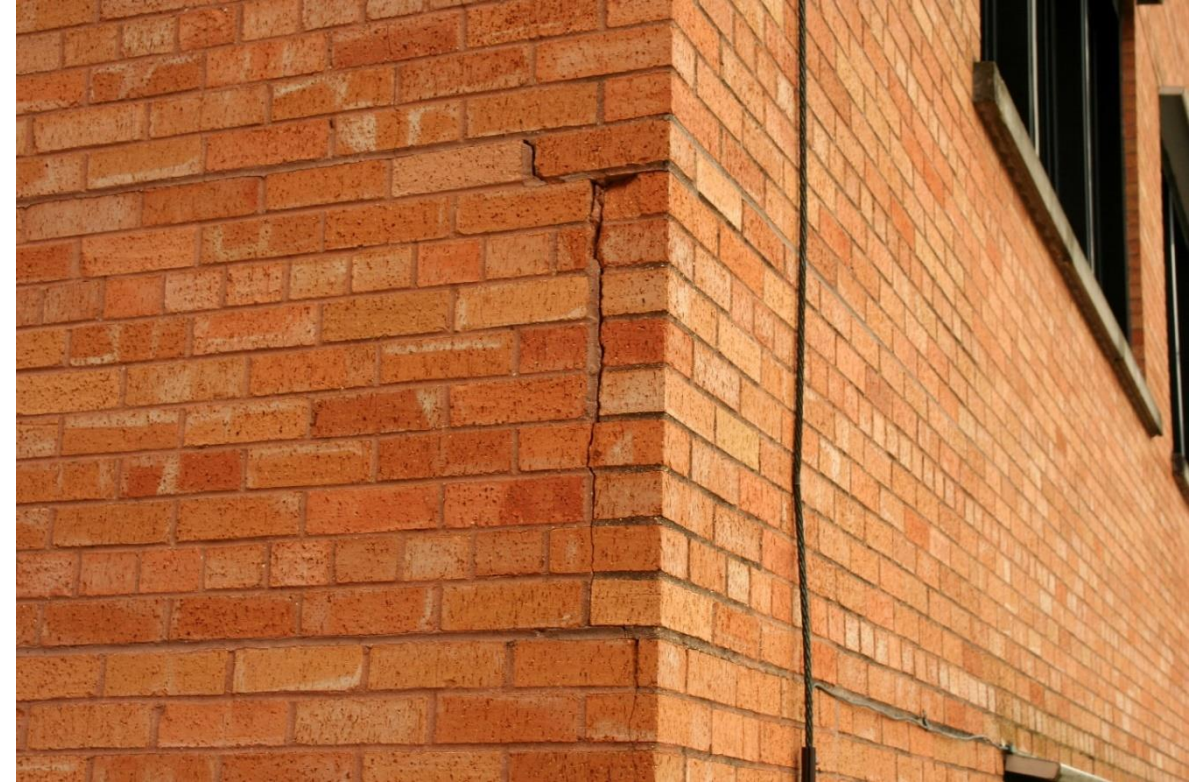
Creates Hinge at Corner

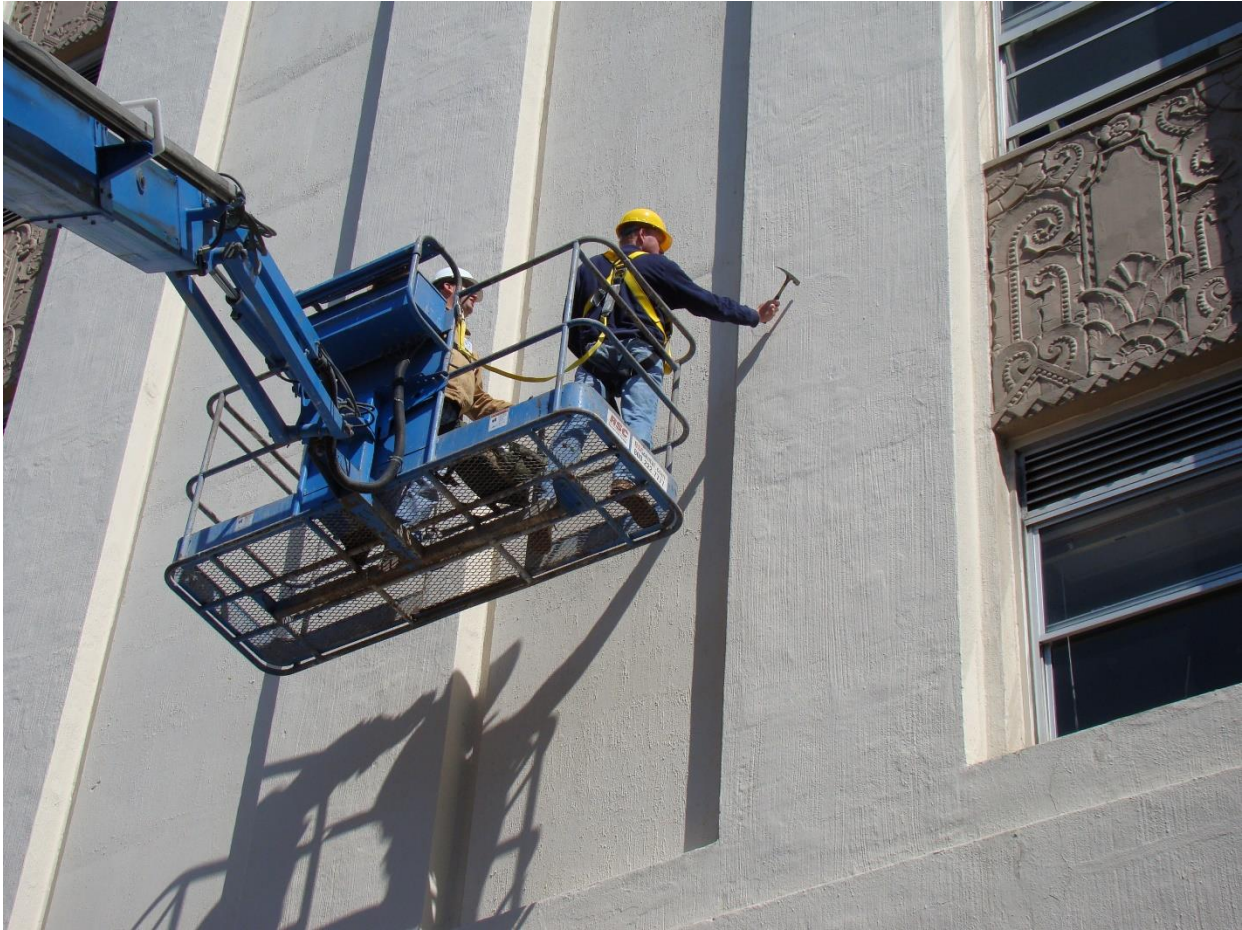
Boom Lift

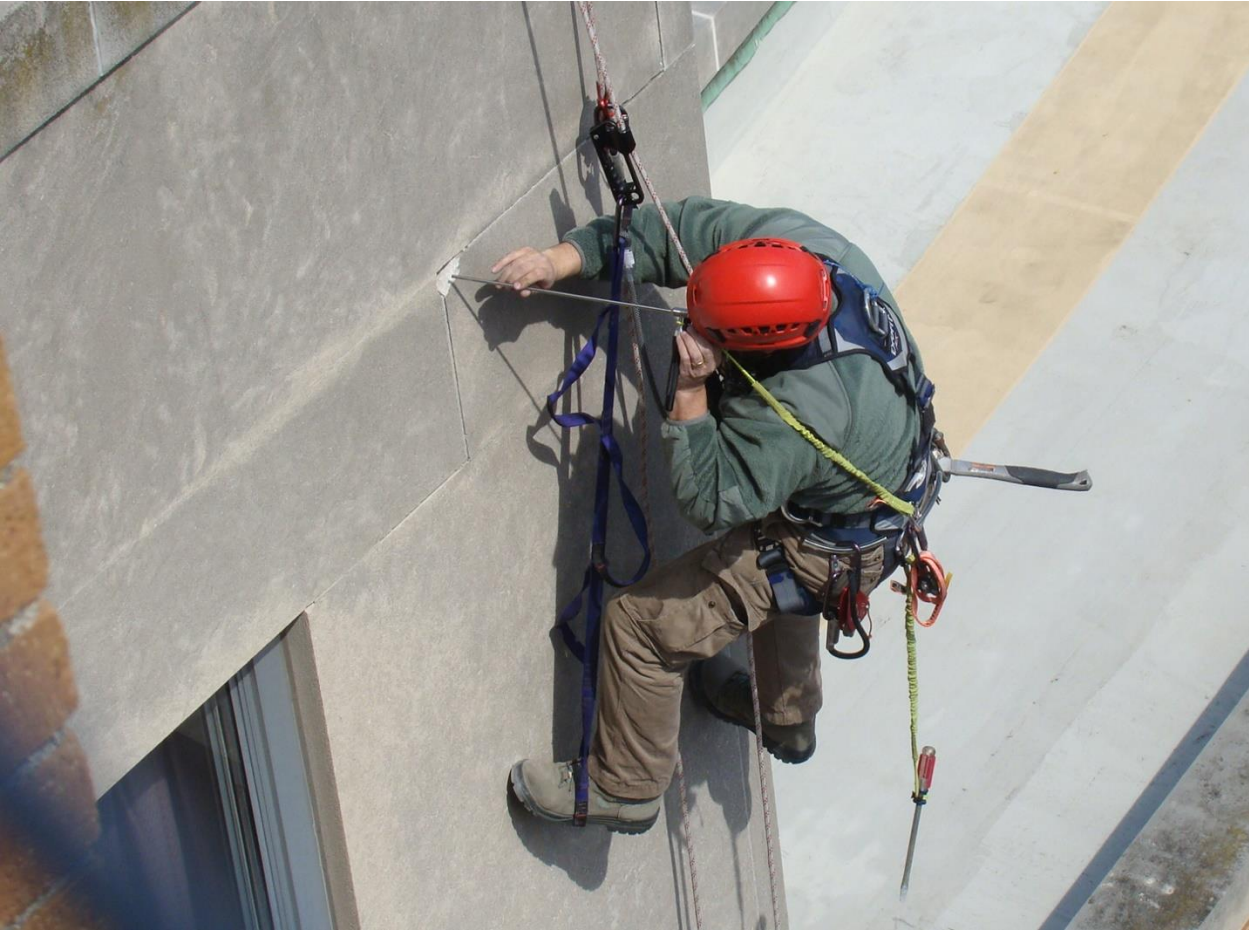
Rope Access

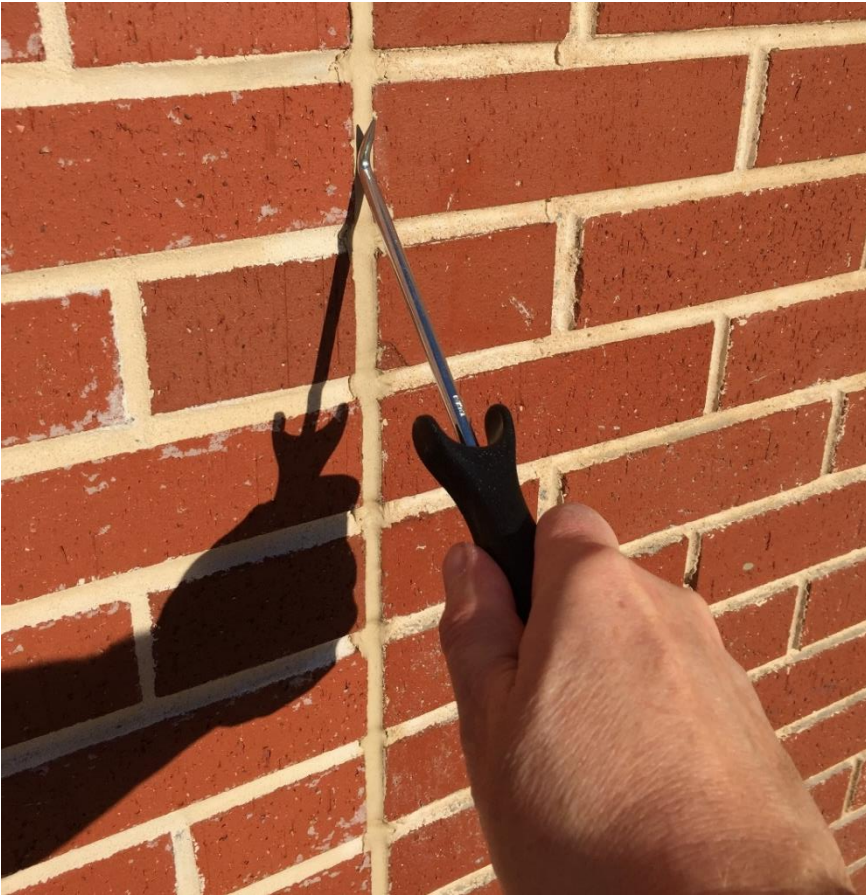
Sealants

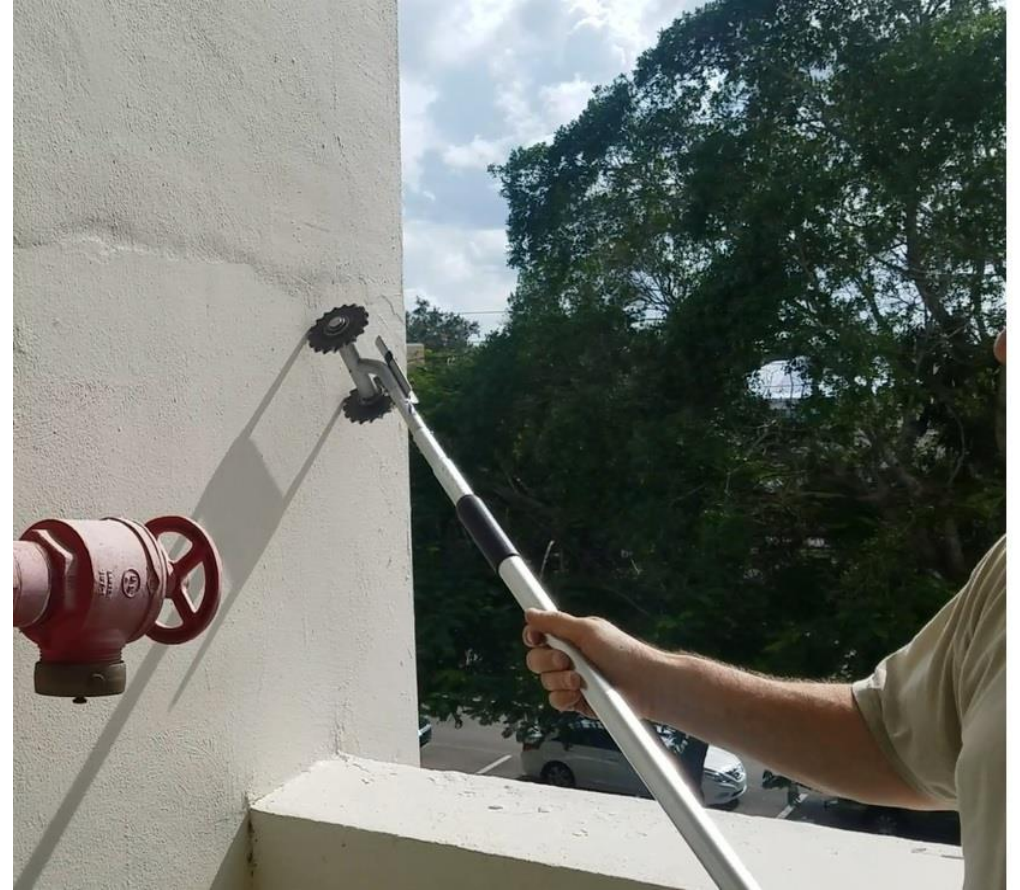
Sounding

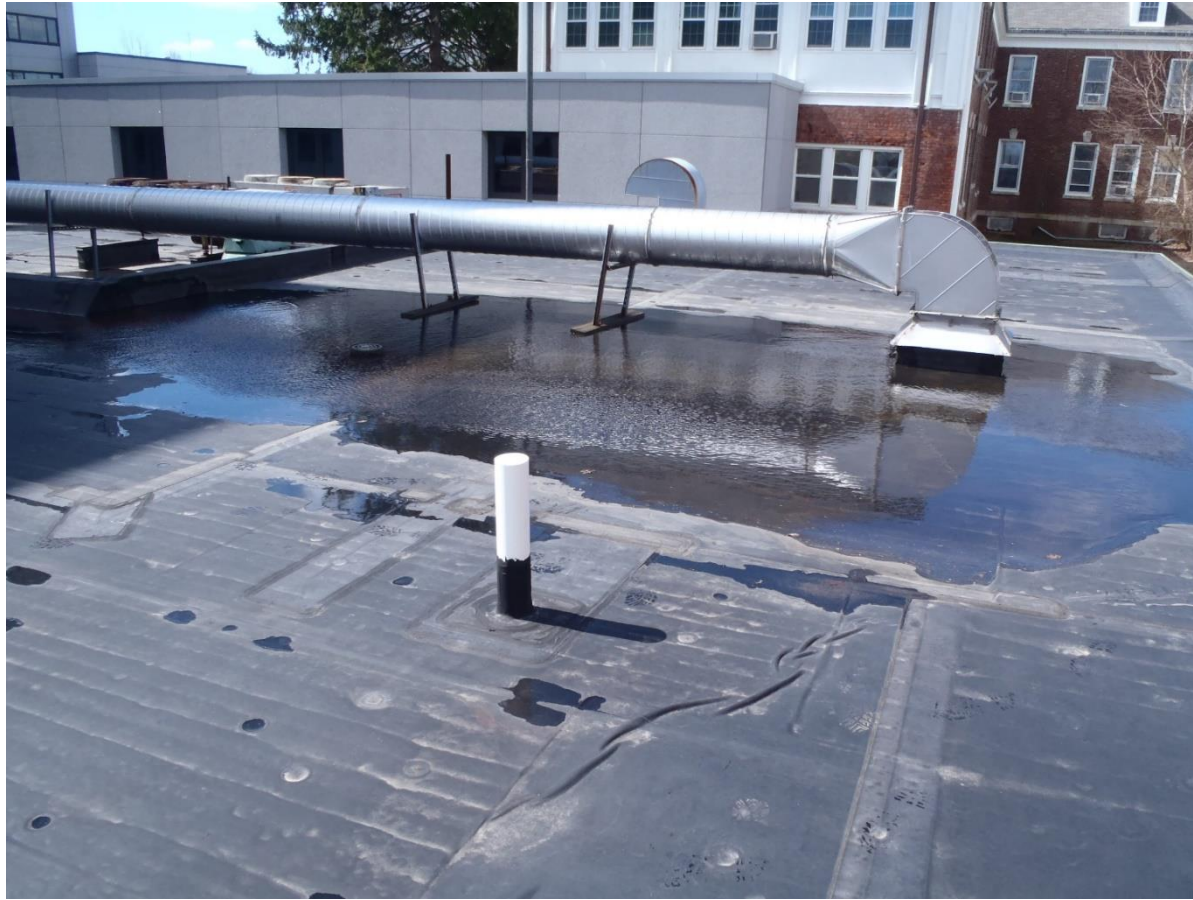
Ponding > 48 Hours

- **Ponding:** Most common factor in roofing failure
- **Water Shedding:** Can make up for shortcomings in design, construction, durability, & maintenance.
- **Degradation:** Asphalt & Polymeric materials
- **Freezing:** Erodes surface aggregate
- **Voids:** Manufacturers warranty

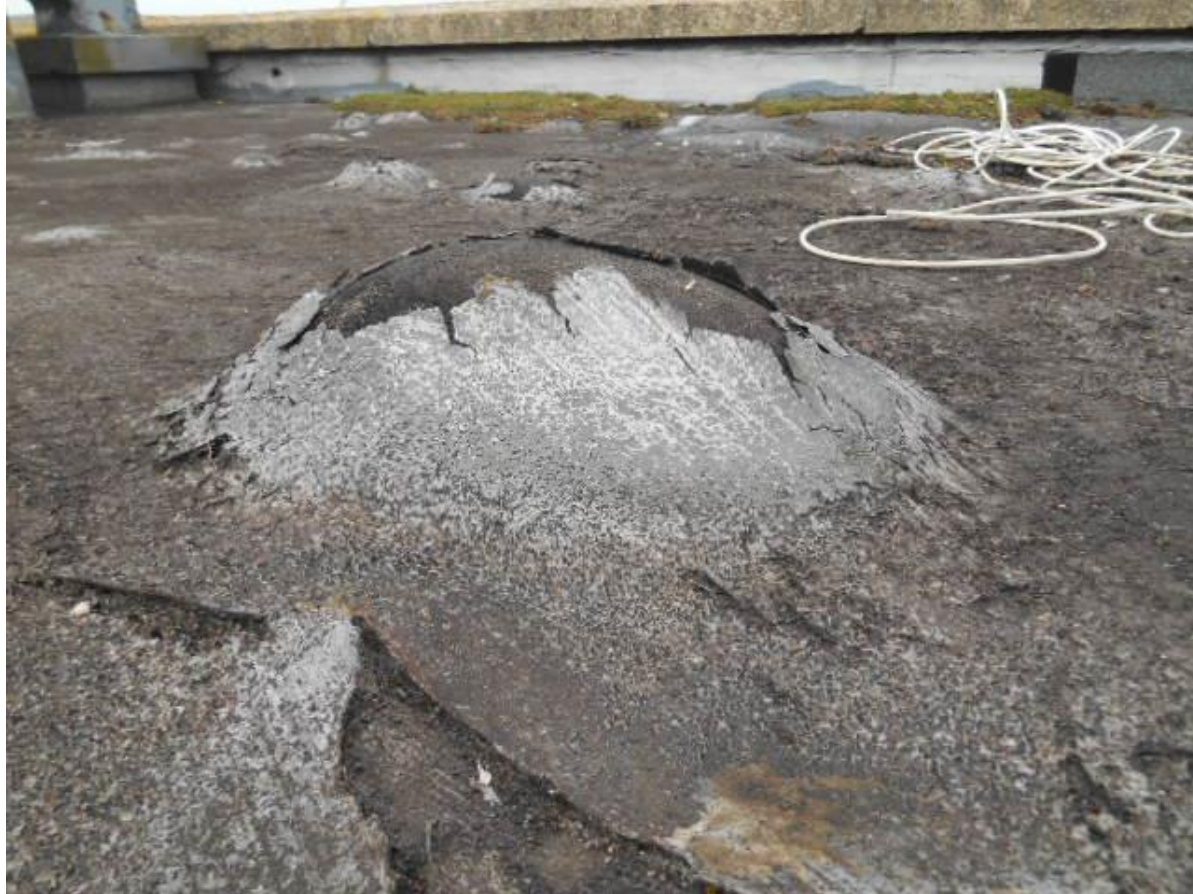
**Blistering**

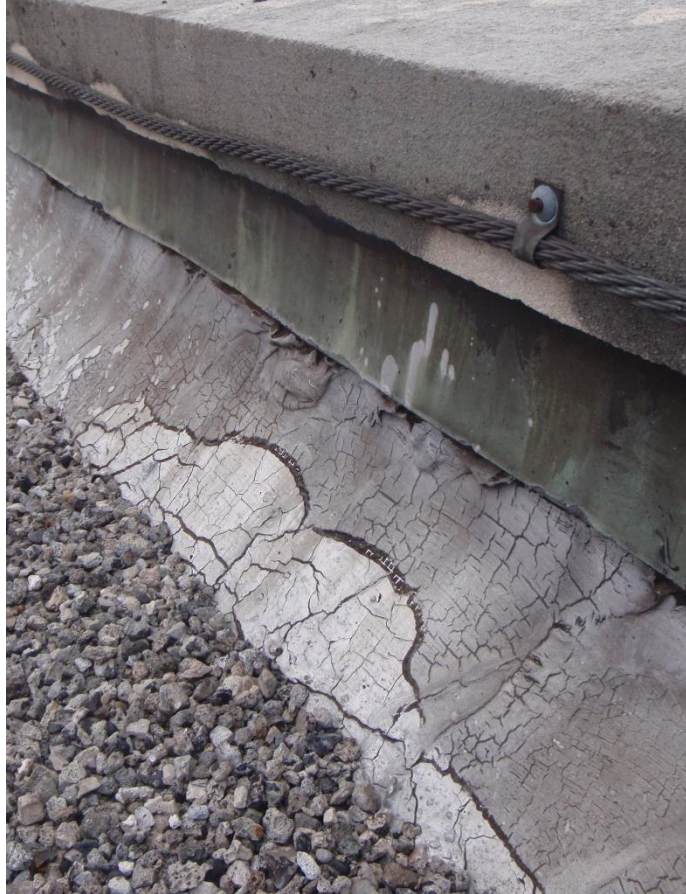
**Slippage**

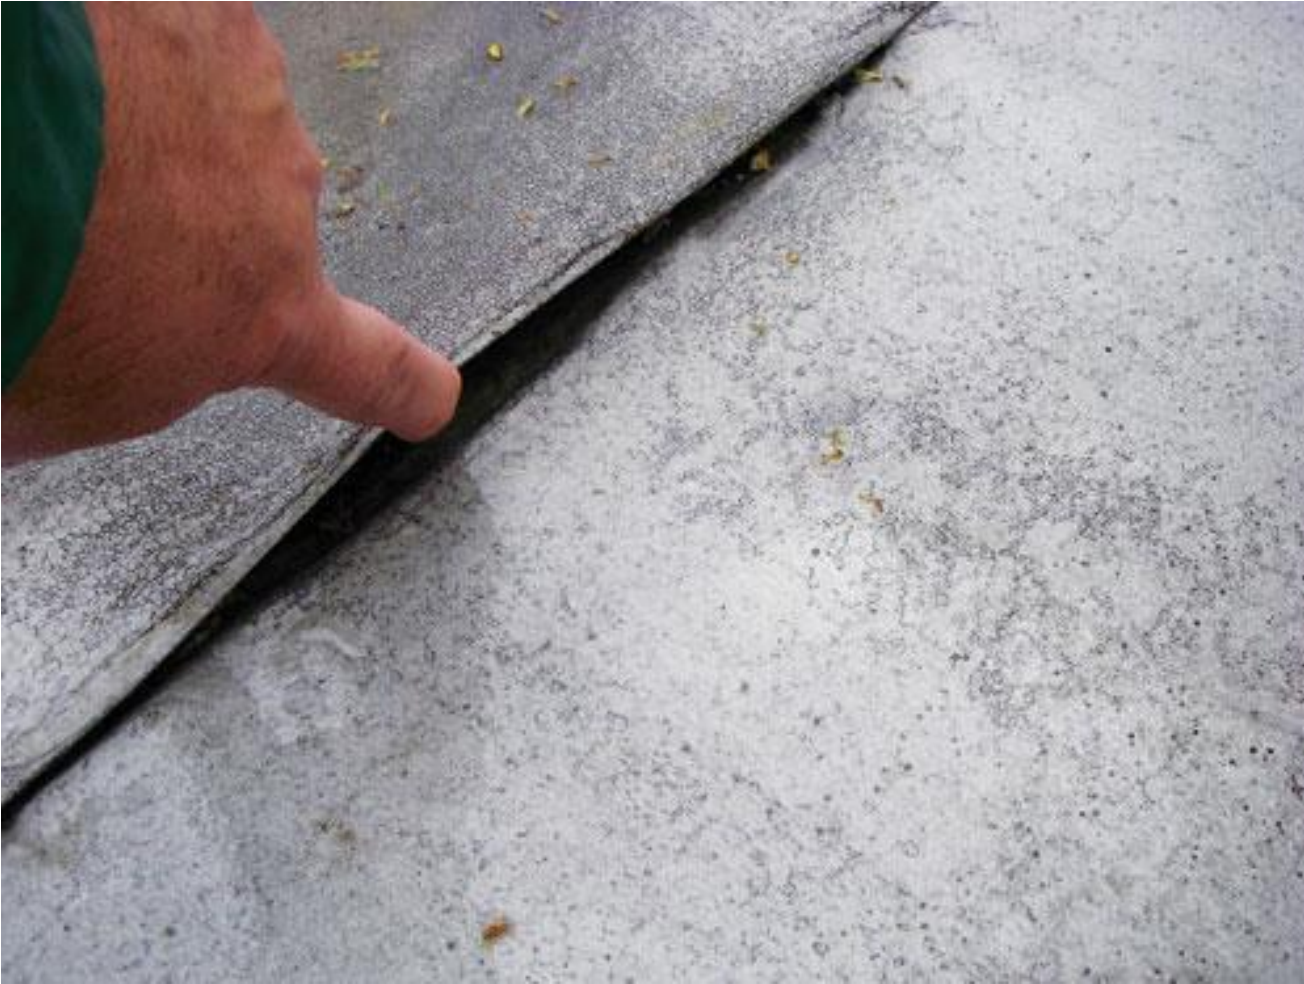
# Roofing - Modified Bitumen

- **Defective Lap Seams**
- Shrinkage
- Checking
- Blistering
- Delamination
- Slippage
- Spitting

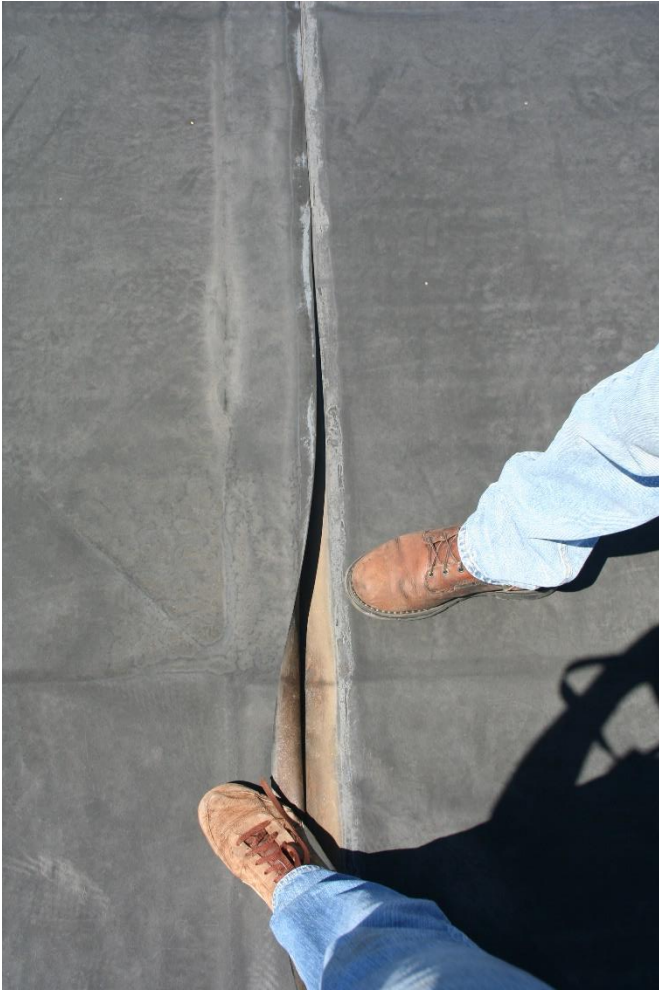
# Roofing - EPDM

- **Lap-Seam Failure**
- Flashing
- Other Common Problems – 8%
  - Puncture
  - Shrinkage
  - Wind Uplift
- Minor Problems @<3%
  - Fastening
  - Blistering
  - Embrittlement

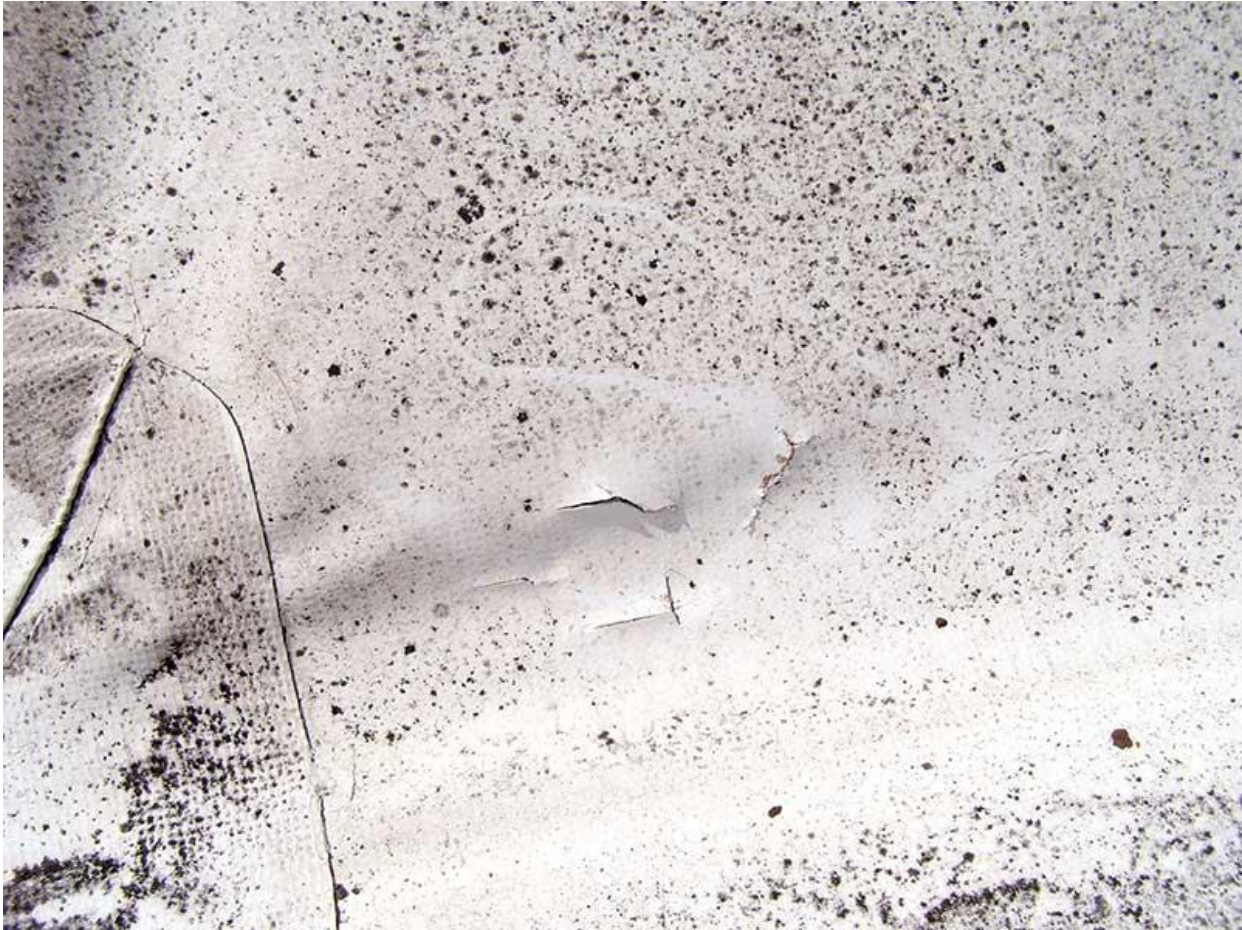
# Roofing - PVC

- **Embrittlement**
- **Puncture**

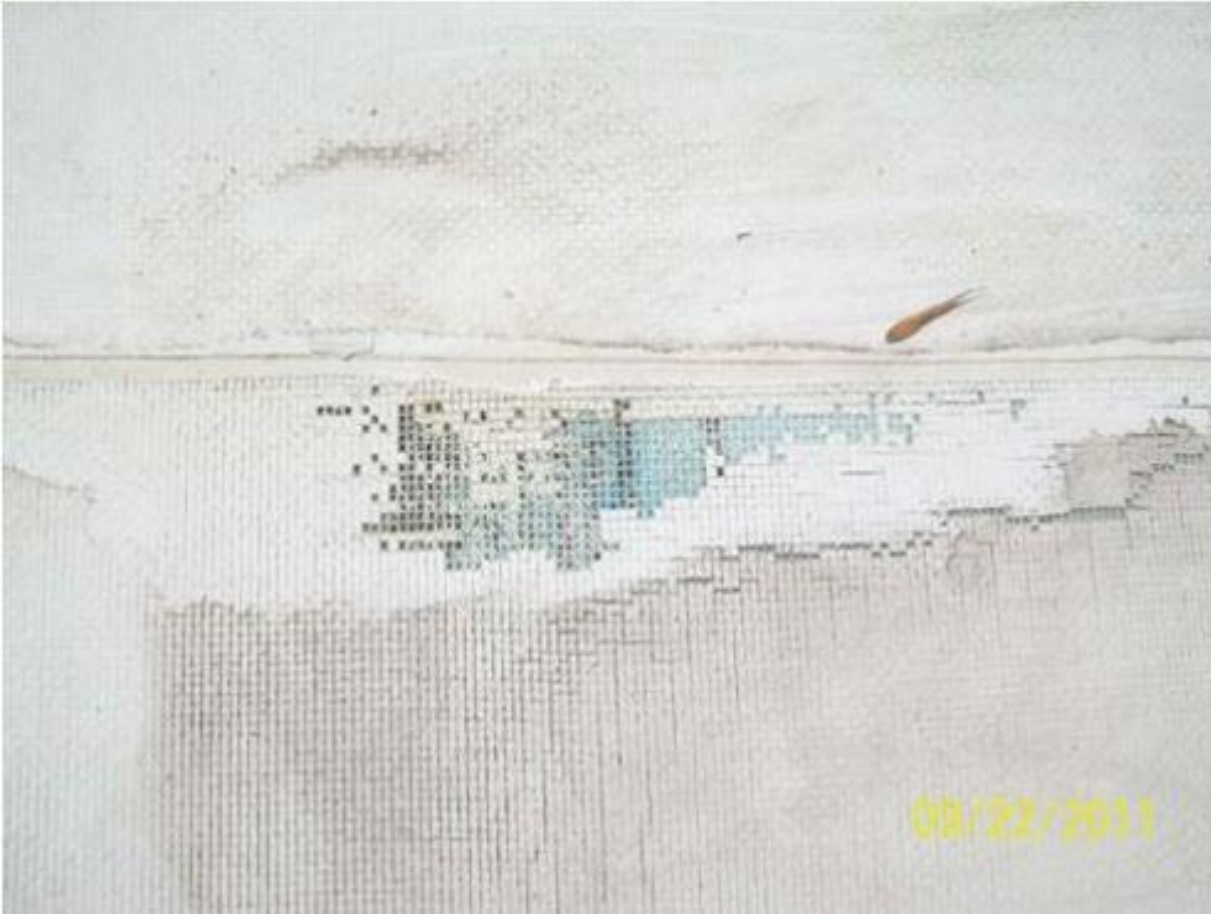
# Roofing - TPO

- **Premature Aging**
  - Erosion of Top Surface
  - Small Holes/Slits
  - Cracking
  - Separation
- **Seam Failures**
- **Newest Roofing Material**

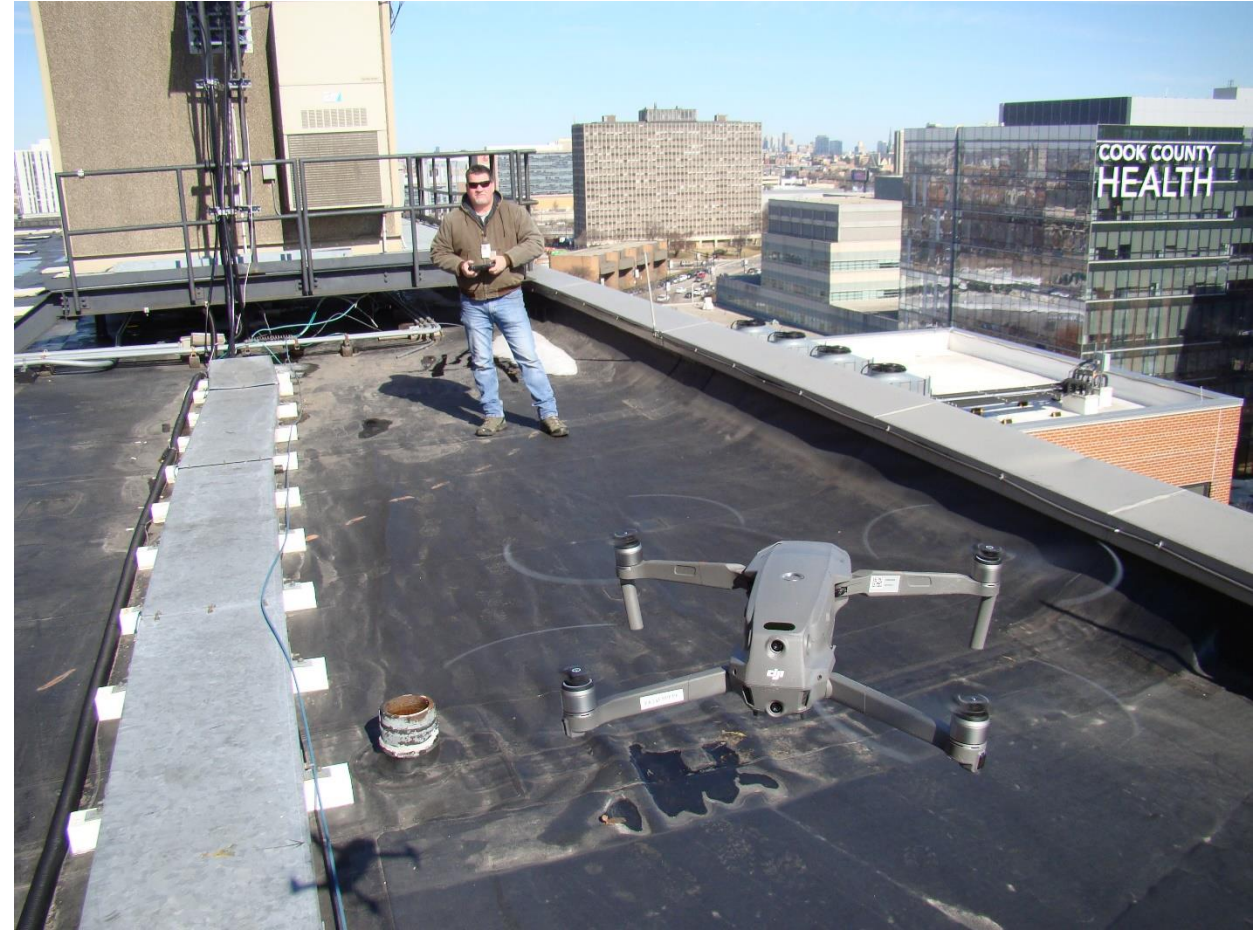
# Roof Inspection - Drone Infrared

- Infrared Camera (IR)
- Best After Dusk
  - Insulation and Moisture Heats Up During the Day
  - Dry Insulation cools off faster than Wet Insulation
- Daylight Waiver Required
- Height to See Major Portions of Roof
- Safer and More Accurate than Handheld

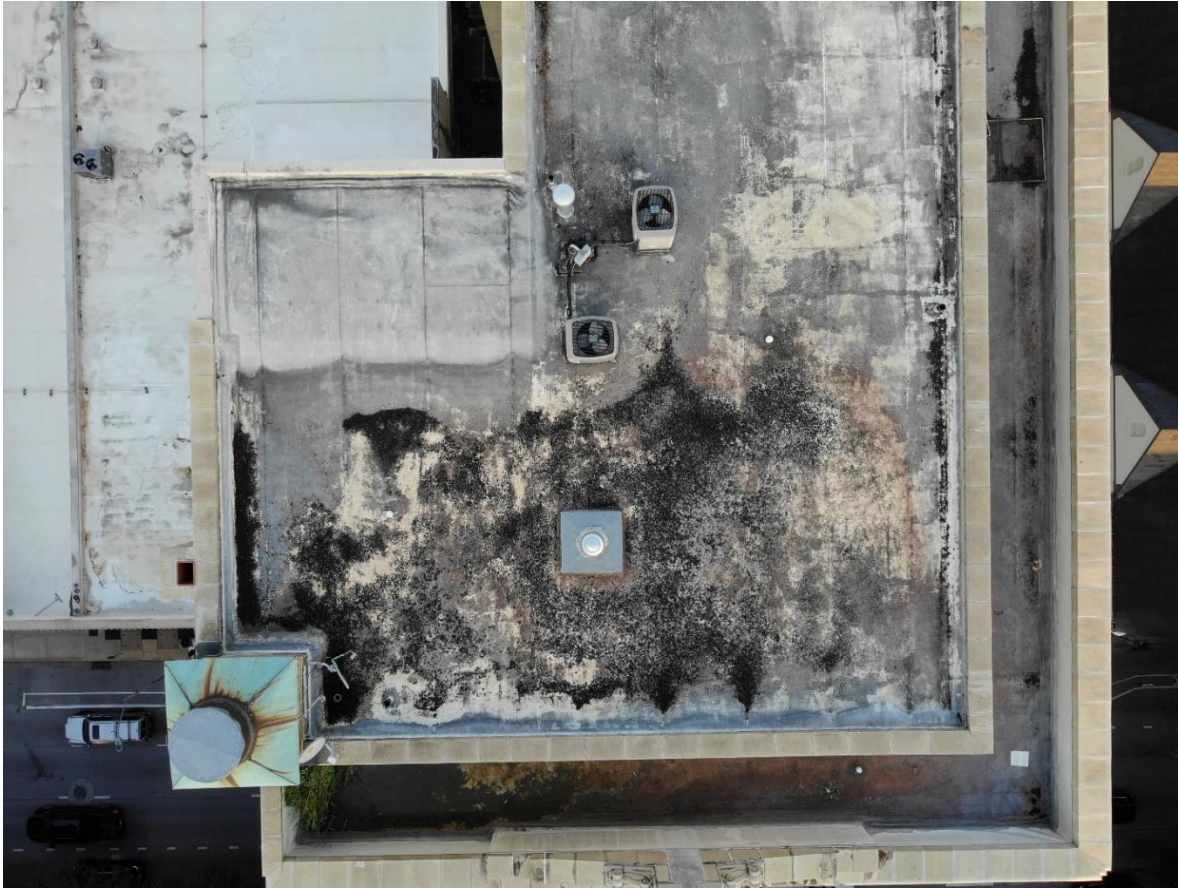
Visual Red-Green-Blue (RGB)

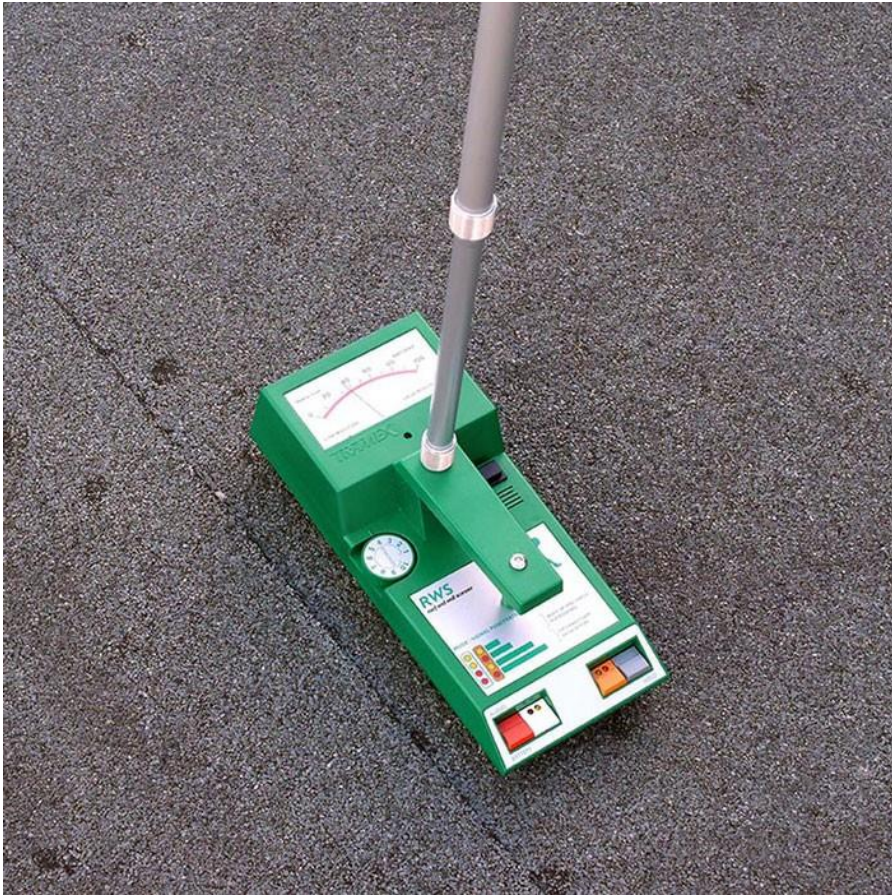
Impedance Meter

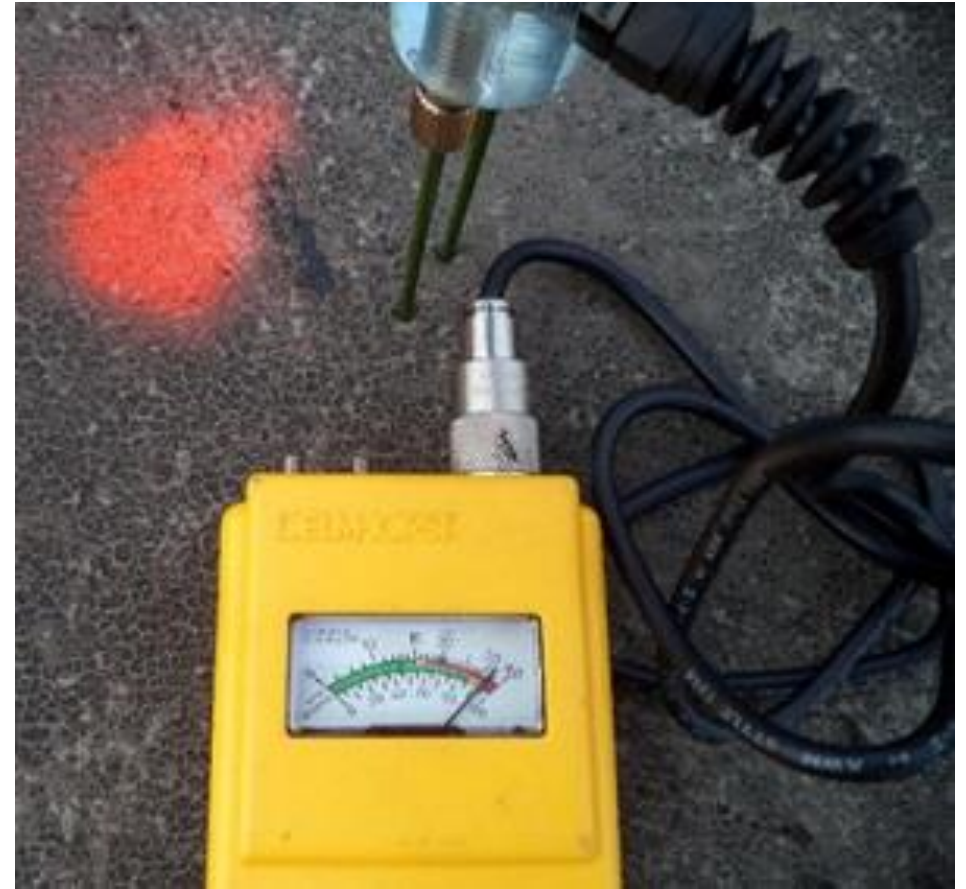
Pin-Type Meter

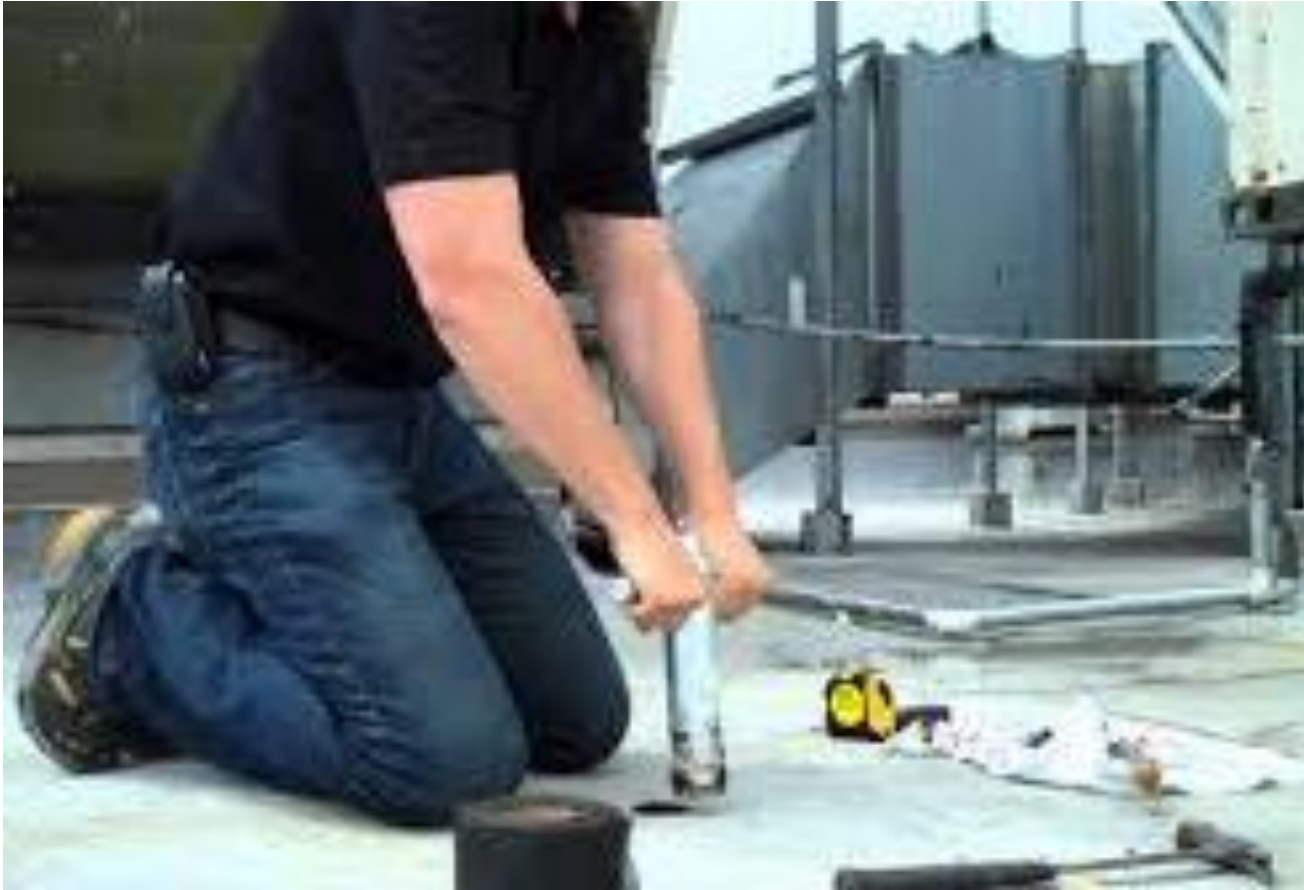
Roofing Core

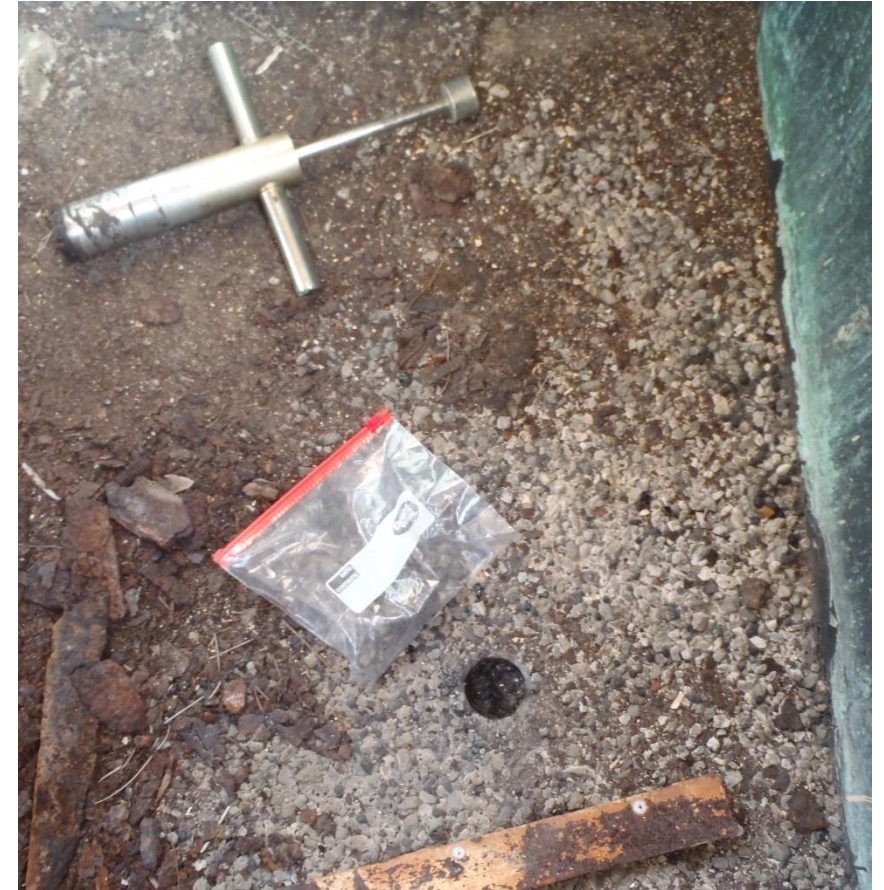
Sample
