# Building Façade Inspection

## Part 2: Procedures

By Scott L. Weiland, P.E., Stephen L. Morgan, E.I. and J. Trey Thomas, E.I.

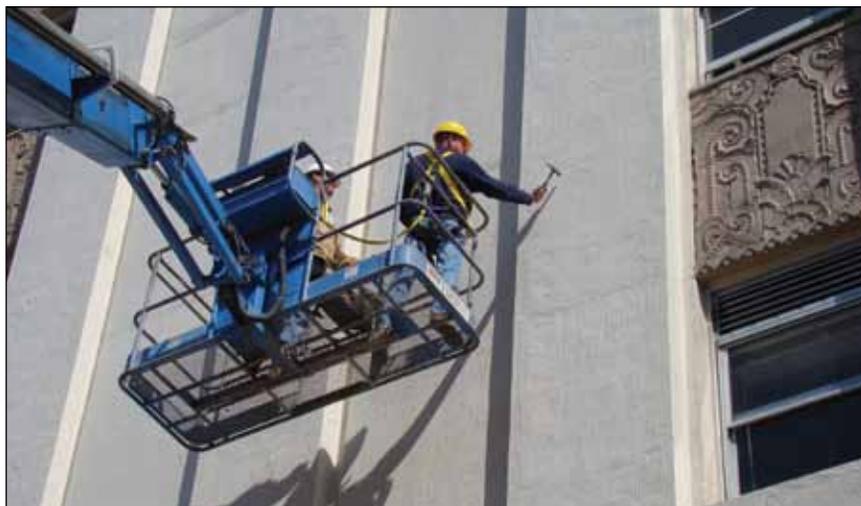
Detailed Façade inspection including sounding for delamination being conducted from a telescoping boom lift.

The degree of inspection is categorized into two levels. *General Inspection* is visual observation at a distance greater than 6 feet from the façade, with and without magnification. *Detailed Inspection* consists of hands-on observation, including pushing, pulling, probing, and sounding, as well as the removal of loose, unsound, or fractured material to examine the underlying cause of the degradation. Initial general and detailed inspection is focused in areas of known and likely deficiencies, both from the interior and exterior of the

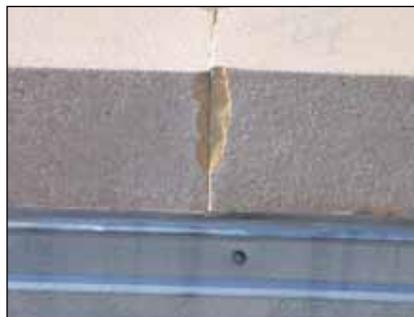
Mortar joints that are too small can cause spalls when terra cotta coping expands.

Detailed inspection of roofing and parapets comes next. Degraded roofing and parapets can be a source of moisture intrusion into the exterior walls, which can cause rust and deterioration of reinforcing and supports; also, moisture trapped within the veneer can freeze or cause the material to expand, resulting in cracks and spalls of the veneer. Parapets experience the full effect of environmental conditions on both faces. Differential temperature and moisture content changes between the parapet and the walls of the building below cause differential expansion and contraction. Modern brick detailing requires standard-width expansion joints in masonry walls every 25 feet and within 10 feet of building corners. Since parapets experience greater amounts of differential movement, a joint spacing of 15 feet is recommended at parapets.

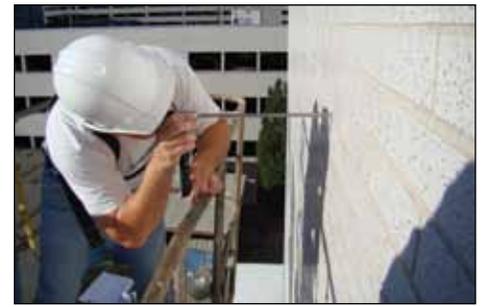
*Detailed façade inspection utilizing borescope examination of veneer supports.*

Based on the findings of the general inspection, previously identified deficiencies, and repair history, representative areas are selected for detailed inspection. The minimum extent is defined in the Annex to ASTM E 2270 according to the age and type of façade material, and may be supplemented by local codes and/or owner requirements. Based on the building heights and access, detailed inspection can be conducted via adjacent roofs, ladder, swing stage, telescoping boom lift, and industrial rope access. At large holes in the façade, mirrors and/or a remote camera can be utilized, when appropriate, to observe and record the substrate condition. Where a remote camera or mirror cannot be used, holes can be drilled in mortar and sealant joints, with the owner's permission, and a borescope inserted to observe and record the substrate. These holes should then be plugged with sealant.
