Presented By: Innovative Engineering Inc.

Florida Parking and Transportation Association 2019 Education Seminar

Learning Objectives

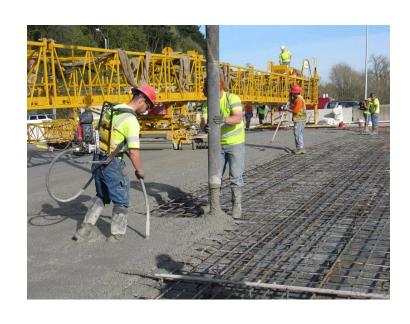
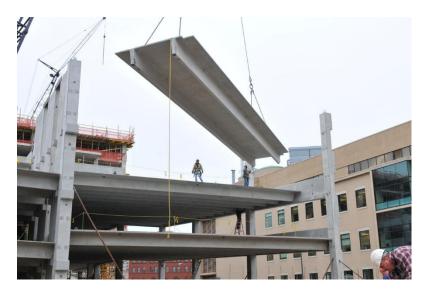
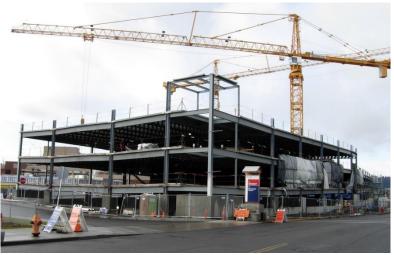
Structural Systems

Cast-in-Place Concrete

Precast Concrete

Structural Steel

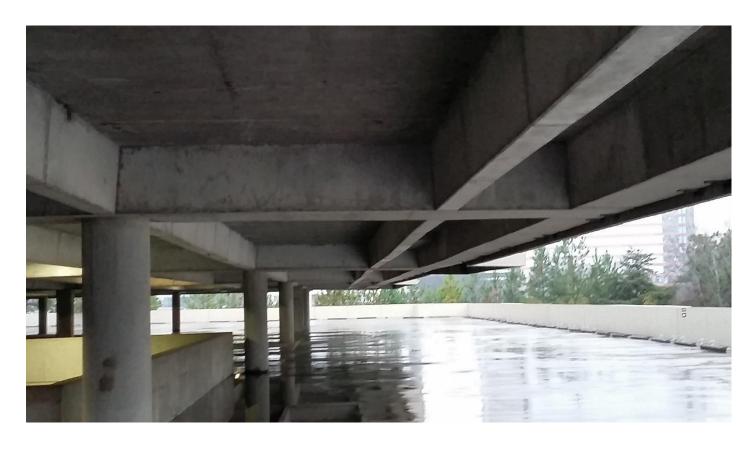
Cast-in-Place

- Flexible Geometry
- Monolithic, Fewer Joints
- Reduced Maintenance Costs
- Longer Life Expectancy
- Higher Durability

- Higher Initial Investment
- Longer Schedule
- More Labor Intensive
- Difficult Quality Control
- Weather Dependent

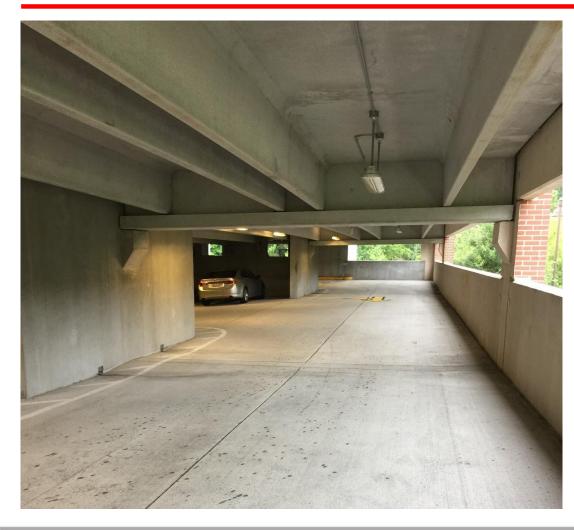
Precast Concrete - Advantages

- Lower Initial Investment than CIP
- Fabricated in Controlled Plant Environment
- Not Weather Dependent
- Accelerated Construction Schedule

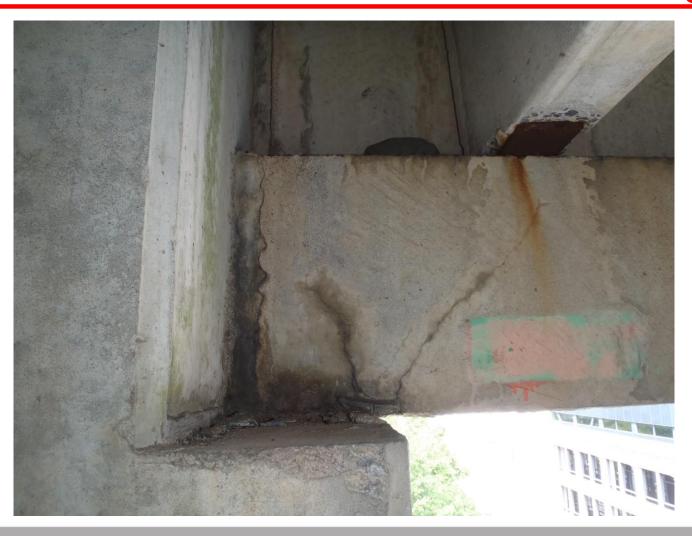
Precast Concrete - Disadvantages

- May be no local plant
- Geometry not Flexible
- Lower Perceived Ceiling heights
- Shearwalls (Closed In)
- More Joints
- Prone to Thermal Expansion & Contraction Damage
- Higher Maintenance Costs

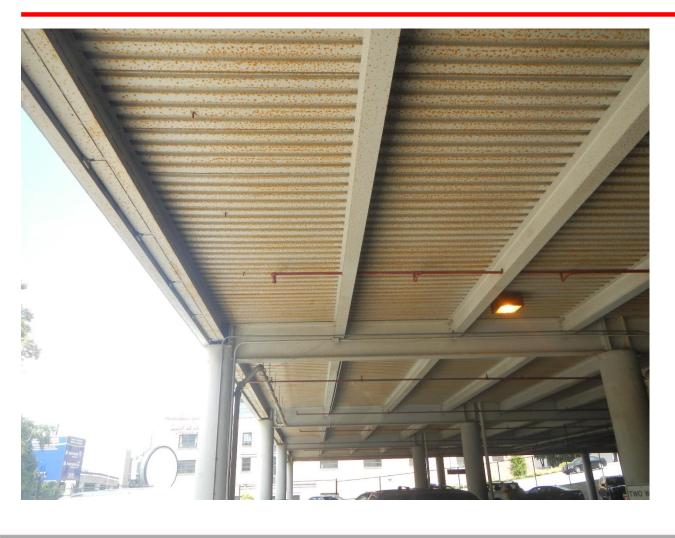
Structural Steel

- Lower Initial Cost than Precast
- Accelerated Construction Schedule
- Fabricated in Controlled Environment
- No Shearwalls (Open)

- Corrosion Issues
- Higher Maintenance Costs
- Not Suitable for Fire Protection

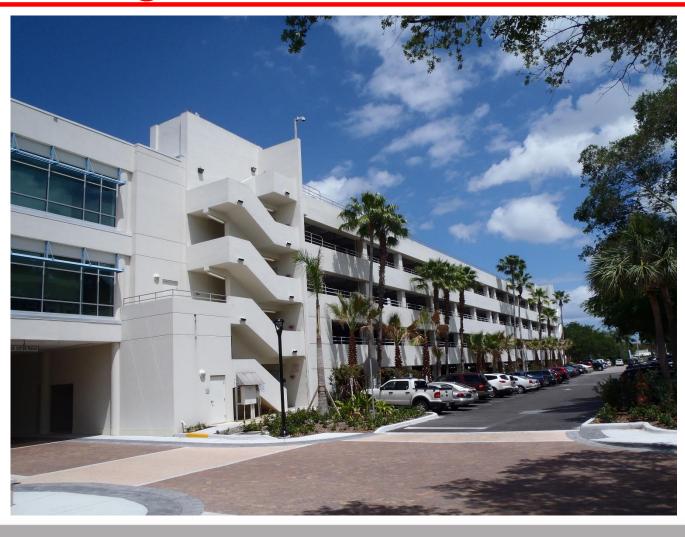
Parking Structures

- Not Bullet Proof
- No Protective Skin
- Deterioration Starts Immediately
- Subjected To:
 - Moisture (Rain, Snow, Ice, Deicing Salts)
 - CO2 Carbonation
 - Extreme Thermal Expansion & Contraction
 - Dynamic Vehicle Loads

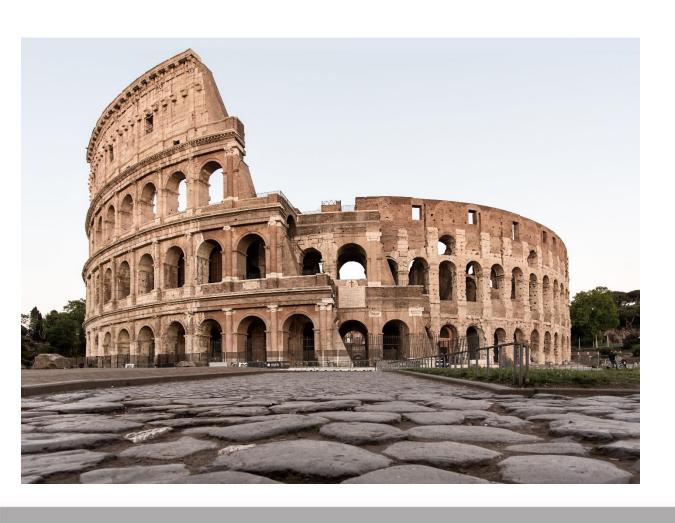
Parking Structures – Roman Structures

- Roman Colosseum
- Over 2000 Years Old
- Mild Climate
- No Reinforcing Steel
- Slow Strength Development

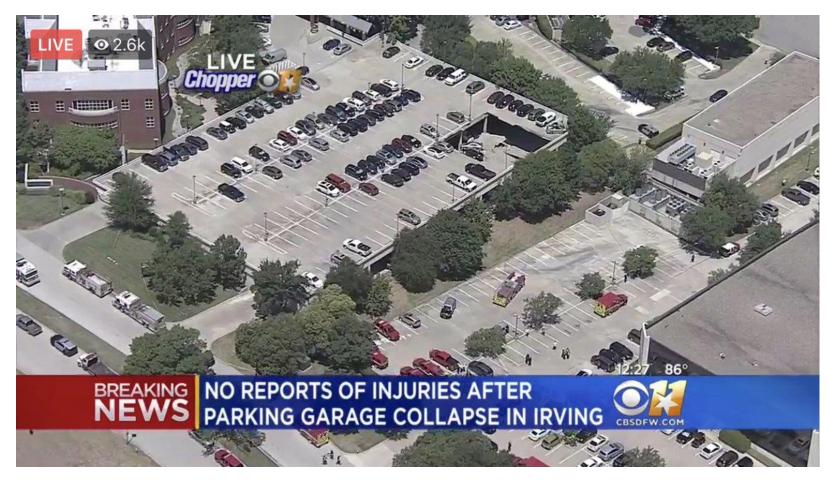
Irving Texas, O'Conner Ridge Blvd. Collapse

- Old Parking Structure
- Expansive Soils in TX
- Exterior Columns Leaning
- Cracks Sealed with Sealant
- No OSHA Report
- Demolished

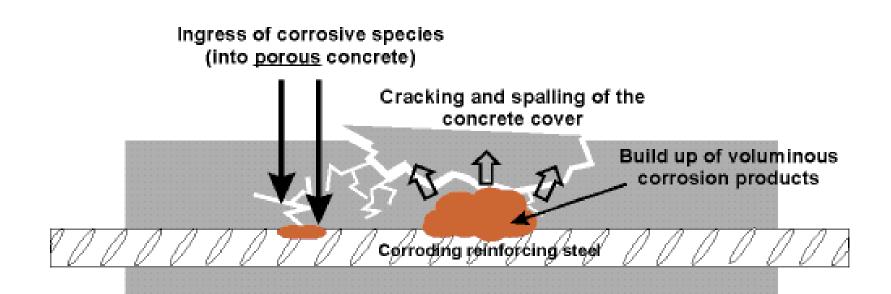
Common Deficiency: Corrosion

A: Spall

B: Crack

C: Corner Spall

D:Delamination

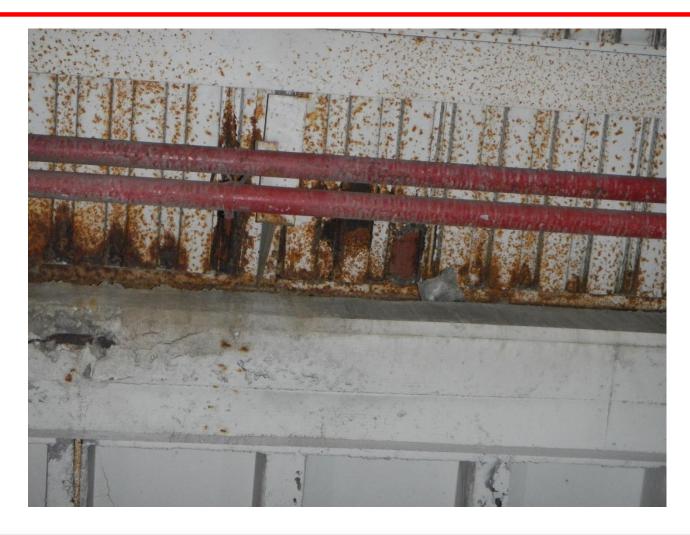
Structural Steel Corrosion

- Steel Protection & Corrosion Issues
- Steel Deck Traps Moisture, Hides Degradation.

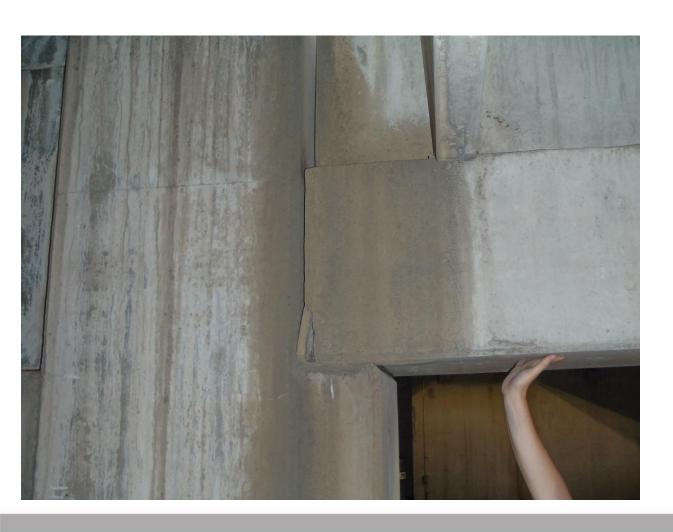
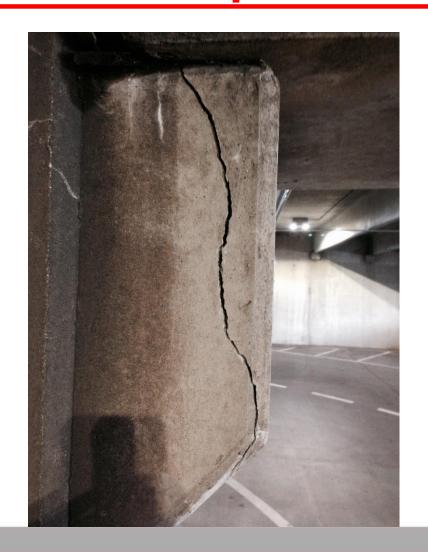
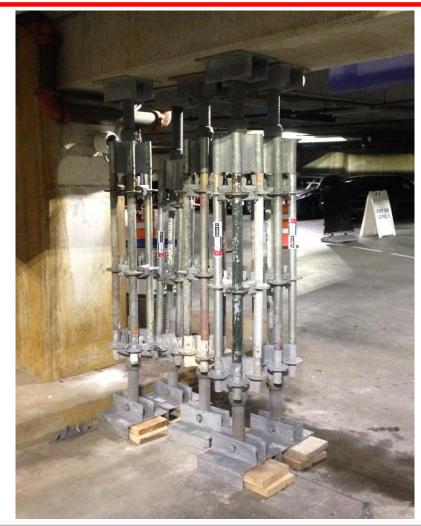
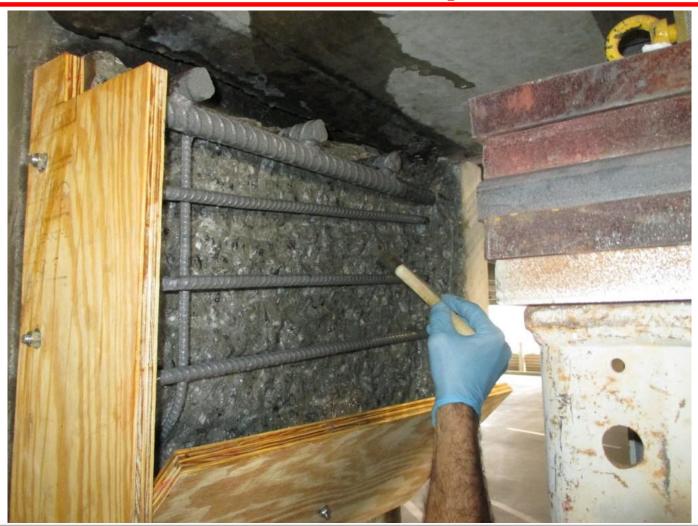
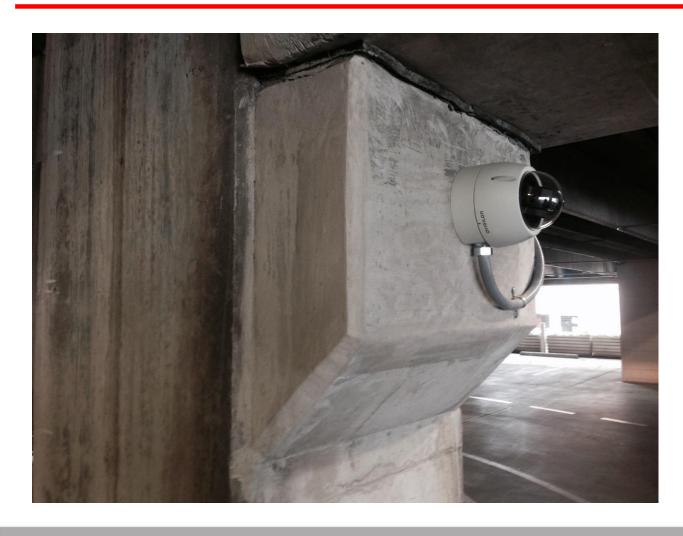
Precast Haunch Connection Failure & Repair

Repaired
