Building Façade Inspection

Part 2: Procedures

By Scott L. Weiland, P.E., Stephen L. Morgan, E.I. and J. Trey Thomas, E.I.

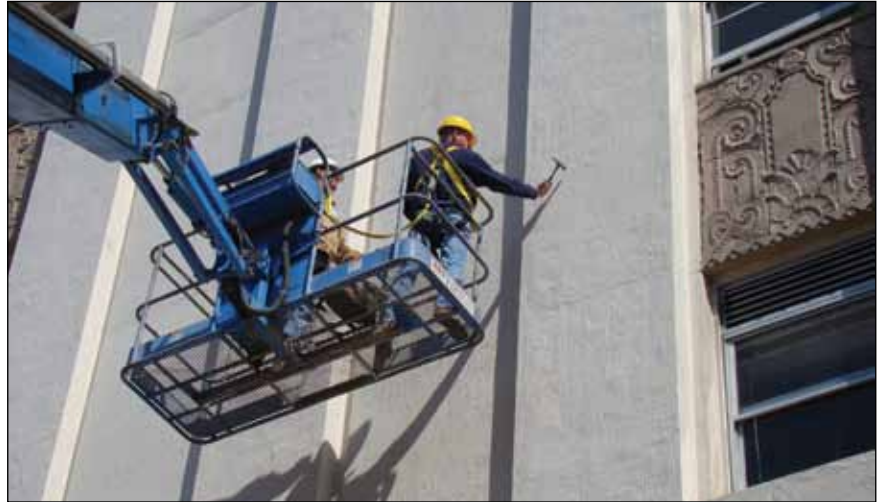
Detailed Façade inspection including sounding for delamination being conducted from a telescoping boom lift.

The degree of inspection is categorized into two levels. *General Inspection* is visual observation at a distance greater than 6 feet from the façade, with and without magnification. *Detailed Inspection* consists of hands-on observation, including pushing, pulling, probing, and sounding, as well as the removal of loose, unsound, or fractured material to examine the underlying cause of the degradation. Initial general and detailed inspection is focused in areas of known and likely deficiencies, both from the interior and exterior of the

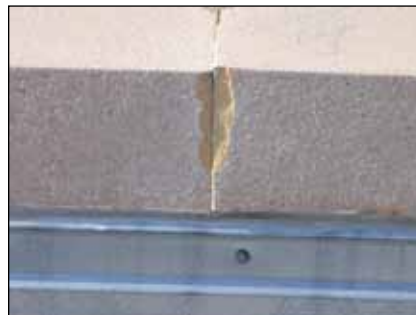
Mortar joints that are too small can cause spalls when terra cotta coping expands.

Detailed inspection of roofing and parapets comes next. Degraded roofing and parapets can be a source of moisture intrusion into the exterior walls, which can cause rust and deterioration of reinforcing and supports; also, moisture trapped within the veneer can freeze or cause the material to expand, resulting in cracks and spalls of the veneer. Parapets experience the full effect of environmental conditions on both faces. Differential temperature and moisture content changes between the parapet and the walls of the building below cause differential expansion and contraction. Modern brick detailing requires standard-width expansion joints in masonry walls every 25 feet and within 10 feet of building corners. Since parapets experience greater amounts of differential movement, a joint spacing of 15 feet is recommended at parapets.

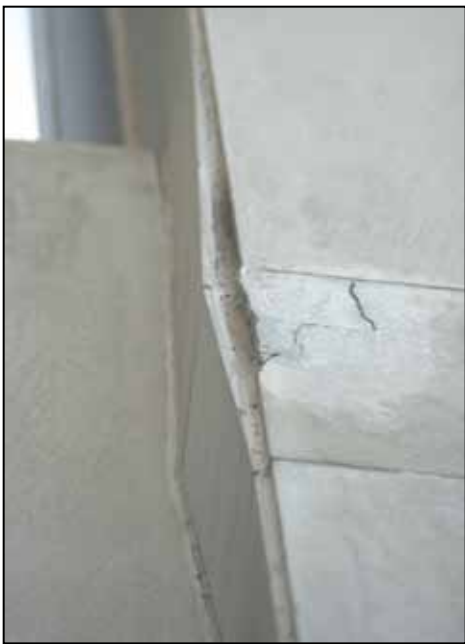
Failure of relief angles above causes limestone curtainwall to buckle under the panel weight from above.

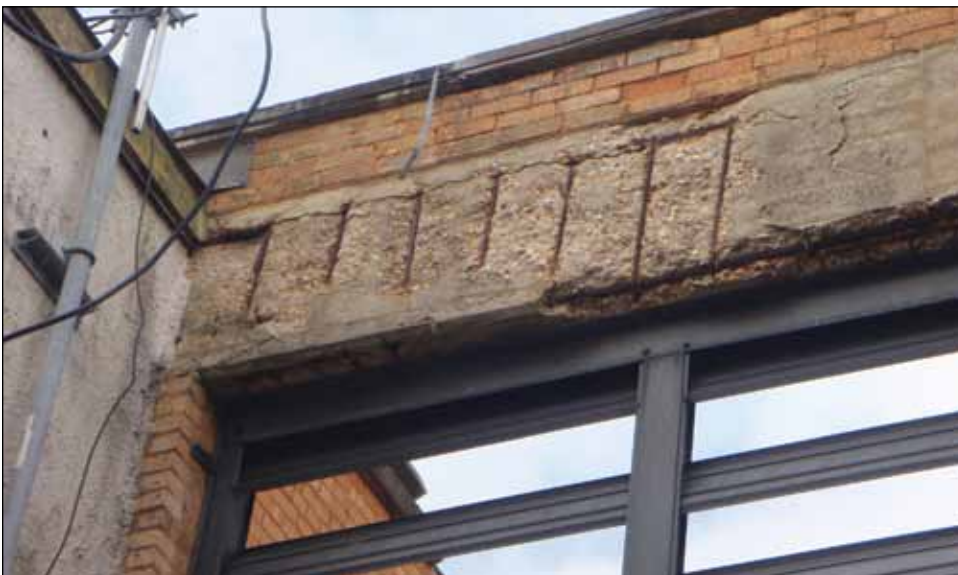
Corrosion of the reinforcing steel has caused the concrete cover to spall.

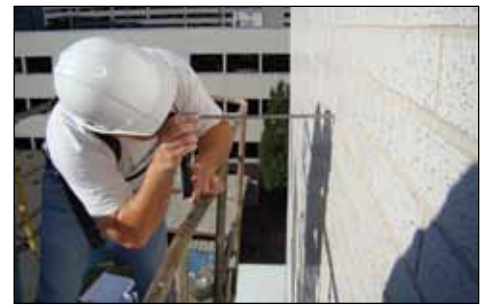
Detailed façade inspection utilizing borescope examination of veneer supports.

Based on the findings of the general inspection, previously identified deficiencies, and repair history, representative areas are selected for detailed inspection. The minimum extent is defined in the Annex to ASTM E 2270 according to the age and type of façade material, and may be supplemented by local codes and/or owner requirements. Based on the building heights and access, detailed inspection can be conducted via adjacent roofs, ladder, swing stage, telescoping boom lift, and industrial rope access. At large holes in the façade, mirrors and/or a remote camera can be utilized, when appropriate, to observe and record the substrate condition. Where a remote camera or mirror cannot be used, holes can be drilled in mortar and sealant joints, with the owner's permission, and a borescope inserted to observe and record the substrate. These holes should then be plugged with sealant.
