## Building Façade Inspection

### Part 1: Considerations

By Scott L. Weiland, P.E., Stephen L. Morgan, E.I. and J. Trey Thomas, E.I.

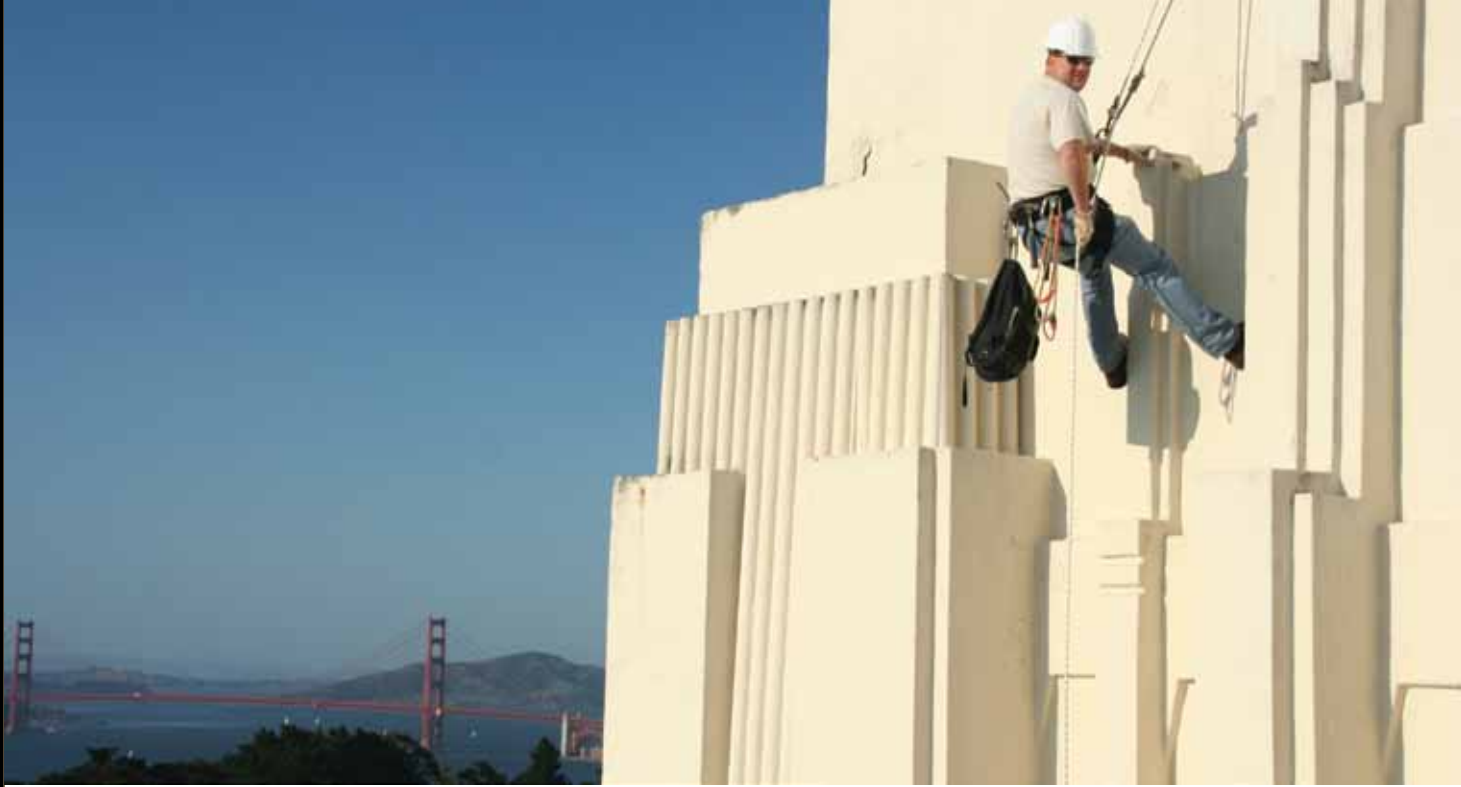
*Engineer conducting façade inspection via industrial rope access. Eight story hospital in San Francisco, CA.*

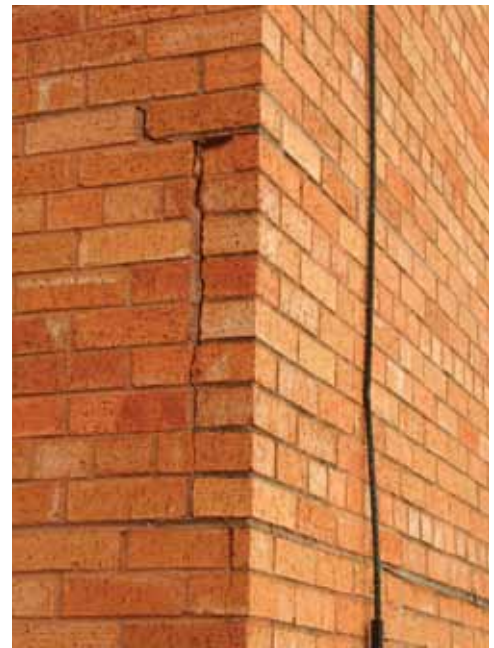
*Cracked corner brick resulting from a lack of expansion joints in the brick veneer.*
