Why is it Raining in my Parking Structure?

• By Scott Weiland

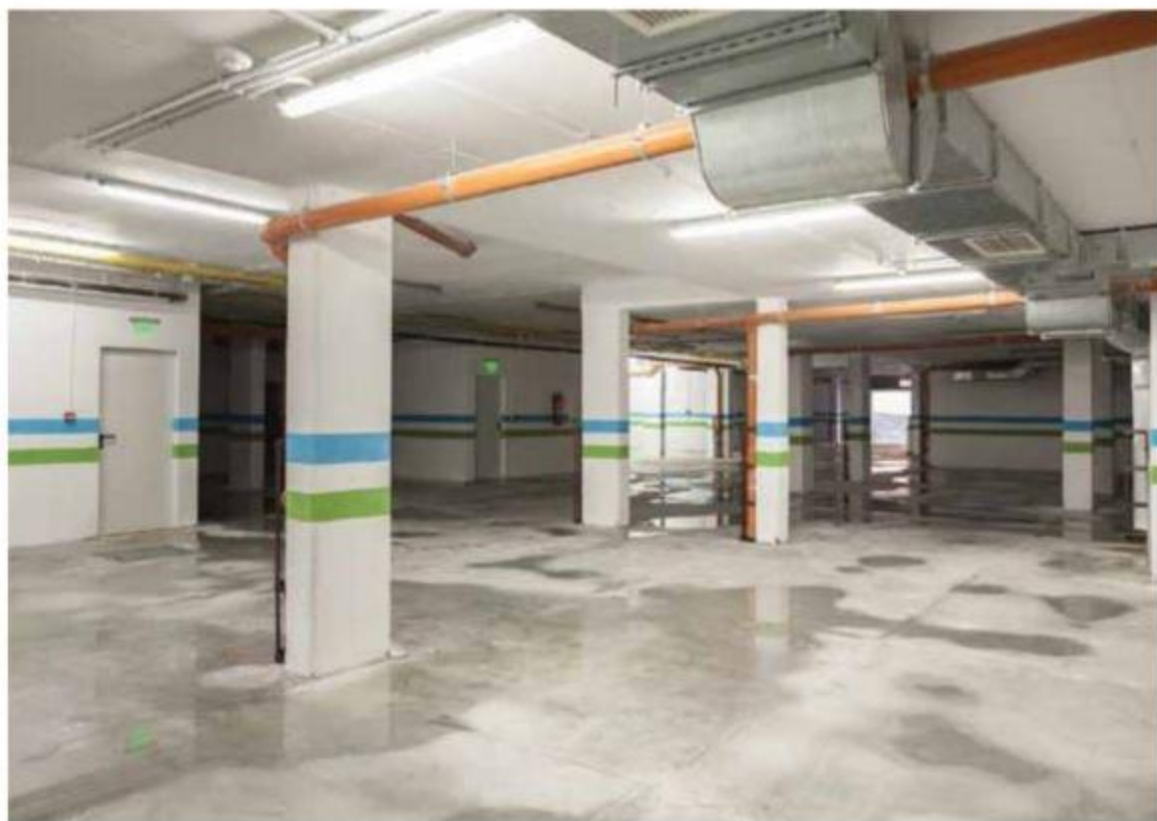
Joints that are expected to move (such as expansion, construction, and control joints) have been historically sealed with polyurethane sealant. A common precast parking structure assembled from many pieces will have many of these joints. It is widely accepted that joint sealant in a parking structure should have a life expectancy of 7 to 10 years, depending on the exposure and the owner's

commitment to maintenance. However, the life expectancy is also dependent on the proper joint design, specification, surface preparation, and installation. Even with material and labor warranties, premature joint failure can result in finger pointing and damaged reputations and should be avoided.
