Building Façade Inspection

Part 1: Considerations

By Scott L. Weiland, P.E., Stephen L. Morgan, E.I. and J. Trey Thomas, E.I.

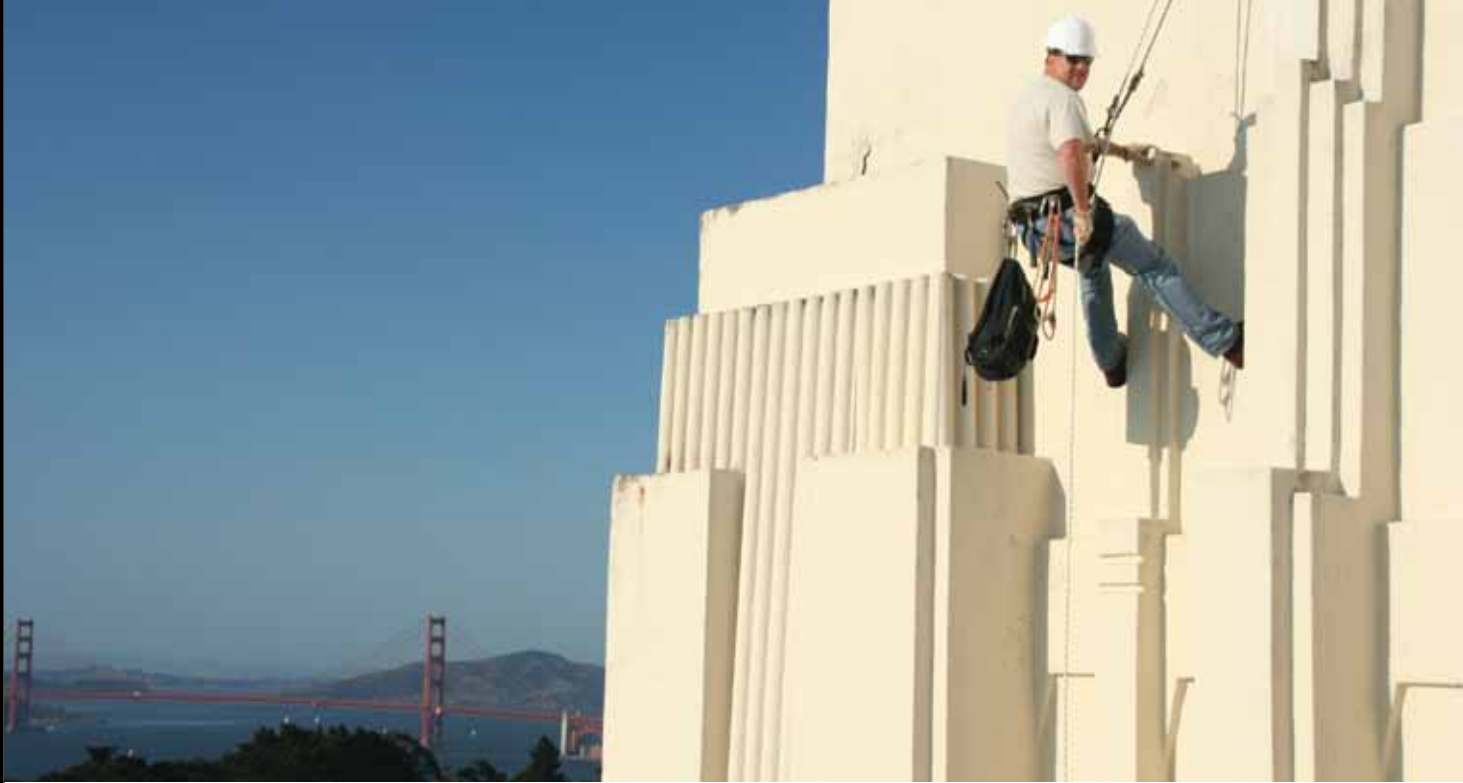
Engineer conducting façade inspection via industrial rope access. Eight story hospital in San Francisco, CA.

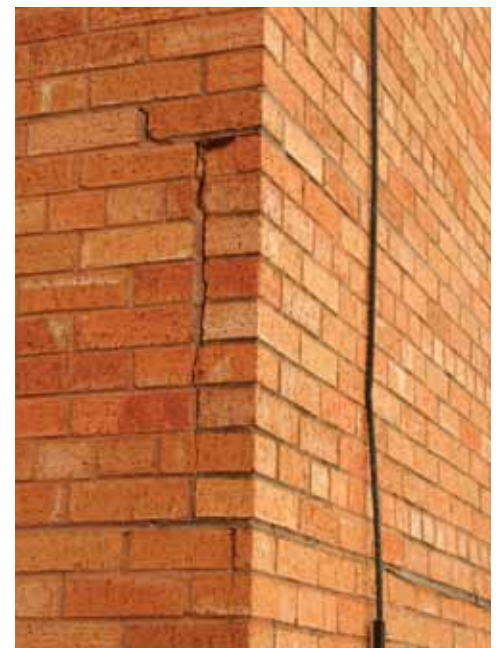
Cracked corner brick resulting from a lack of expansion joints in the brick veneer.

All materials expand and contract with changes in temperature. Fired clay, such as brick and terra cotta, and some stone products, such as granite and limestone, have thermal expansion coefficients similar to that of concrete masonry (CMU). Marble and steel have coefficients higher than that of CMU. Aluminum, often used in window and curtain wall framing, has a thermal expansion coefficient approximately three times that of CMU. Exterior cavity walls have the insulating value of an air space and thus will experience a larger temperature differential between the interior wythe, which is exposed to conditioned air, and the exterior wythe, which is exposed to the atmosphere, than a solid un-insulated wall. This can be greatest on a dark-colored, south-facing wall, where surface temperatures can be as much as 40°F above ambient. An insulated 4-inch veneer will have an average temperature roughly equal to the exterior surface temperature. A solid, uninsulated wall will have a lower mean temperature than the exterior surface due to the competing interior and exterior temperatures.
